GSP9702 and GSP9712 Service Manual

HUNTER
Engineering Company

This manual will assist service personnel in repairing and troubleshooting the GSP9700 Series (GSP9702 and GSP9712) Vibration Control System.

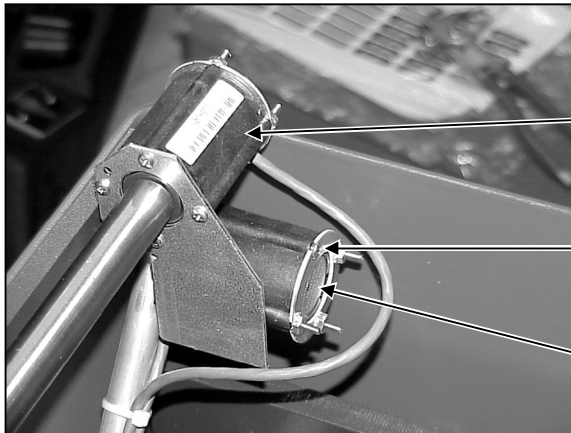
RADIAL HALL EFFECT SENSOR

THIS SCREW MUST BE INSTALLED IN THE OPPOSITE DIRECTION TO AVOID RUBBING ON THE WEIGHT TRAY

LATERAL HALL EFFECT SENSOR

3. Disconnect the sensor wire from the interconnect board, (J6 for lateral sensor, J7 for radial sensor).
4. Remove the four nuts, 76-59-2, holding the retainer, 41-112, in place.
5. Remove the retainer.
6. Gently remove the sensor, 125-299-1, by grasping the extruded plastic pin with needle nose pliers, while gently pulling on the sensor wire.

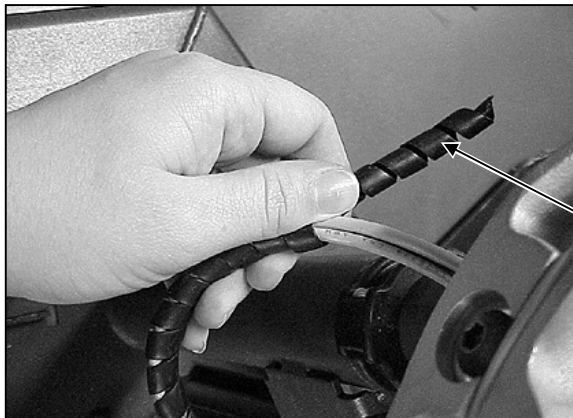
6. Remove the black spiral wrap, 70-143-2, from the outer Dataset® arm wires.

SPIRAL WRAP,
70-143-2

1. Route the Hall effect sensor wire through the outer Dataset® arm shaft and into the balancer base. Reinstall the black spiral wrap, 70-143-2.
2. Connect the sensor wire to the interconnect board, (J3 for the outer lateral sensor, J4 for the outer radial sensor).
3. Position the brass Phillips head screw, 75-508-2, into the center of the magnet assembly, 176-35-1. Verify the key molded in the magnet assembly is positioned into the keyway of the shaft. Tighten the screw.
4. Place the O-ring in the opening.
5. Place the new sensor, 125-299-1, into the opening.
6. Replace the previously removed snap ring, 112-84-2.
7. Reconnect the power cord to the power source.
8. Calibrate the GSP9700 outer Dataset® arm.

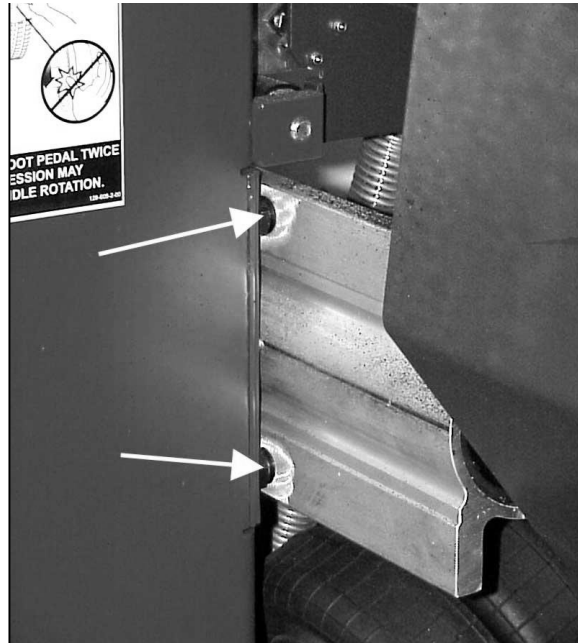
2. Prior to making any adjustments, make sure the spacer nuts on the backside of the aluminum bearing housing are snug, but not tight, to the cabinet.

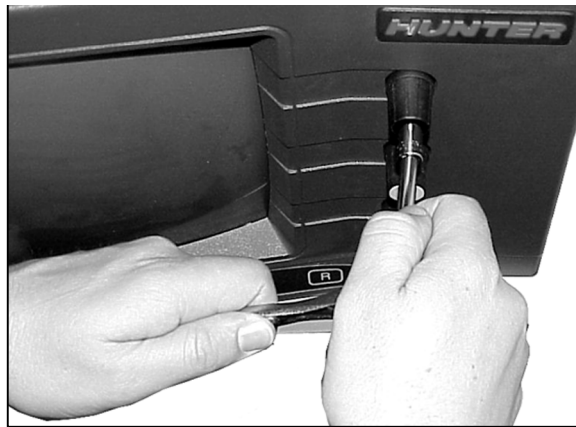
6. Remove the outer knob assembly by turning the nut counterclockwise while holding the knob. Repeat for the two remaining knobs.

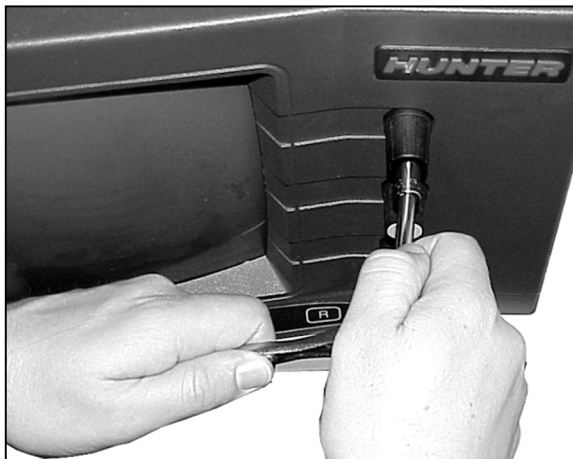
When tightening the brass nut, the knob will tend to tighten itself against the bezel. To prevent binding, maintain a space (about the thickness of a piece of paper) between the knob and the console while tightening the brass nut.

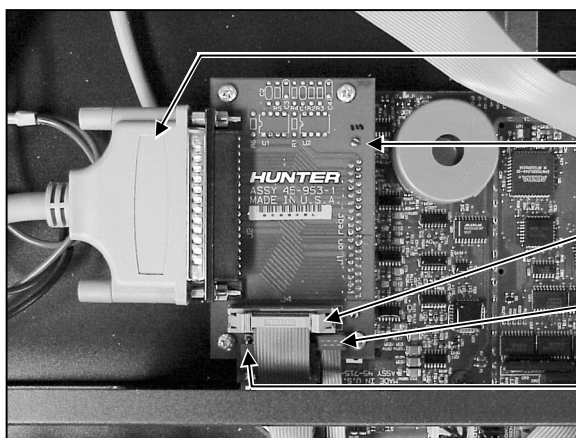
1. Disconnect the power cord from the power source.
2. Remove the monitor and the top cover from the CRT support console.
3. Disconnect the blue ribbon cable from J4 of the knob interconnect board.

- 37-PIN DSUB CABLE TO INTERCONNECT BOARD
- KNOB INTERCONNECT BOARD, 45-953-1
- BLUE RIBBON CABLE TO GSP BOARD
- KEYPAD RIBBON CABLE
- RIBBON CABLE (UNDERNEATH) TO CONTROL KNOB

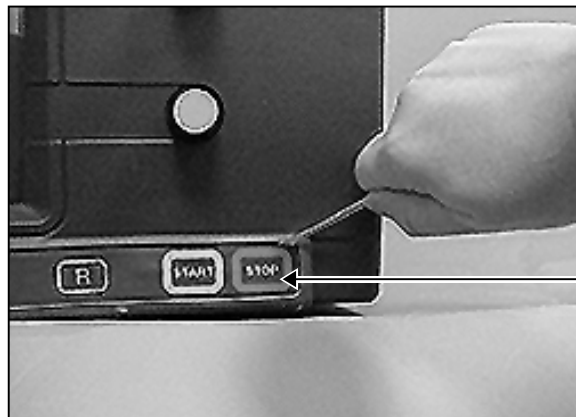
1. Disconnect the power cord from the power source.
2. Disconnect the keypad cable from the knobs board, 45-779-1, by gently pulling down on the ribbon cable connector.
3. Using a thin screwdriver, gently pry an edge of the keypad off the GSP console.

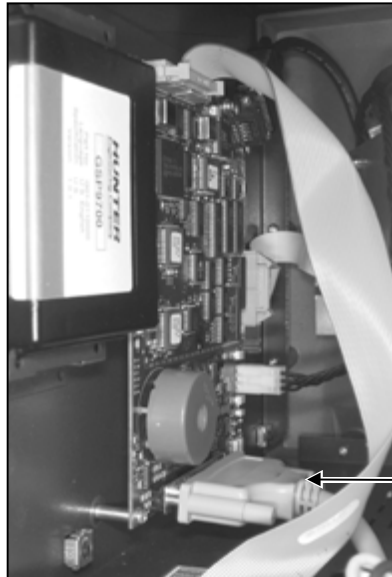
DATA CABLE

1. Remove console from cabinet. Refer to "Remove Console from Cabinet," page 2-35.

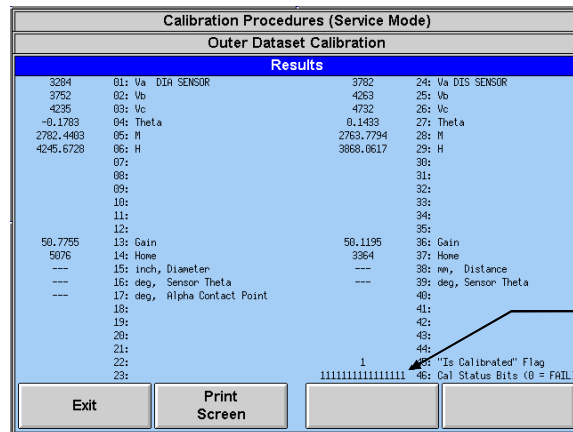
Outer Dataset® Arm Calibration Failure

Bit 6 is verifying that the difference between item #37 and #26 on the Cal Data screen is within tolerance. This bit checks the readings in lateral step 1 and the initial storing of the home settings of the Outer Dataset calibration. **If this bit fails, there is something wrong with the outer Dataset® distance sensor circuit or the correct calibration sequence was not followed.**

NOTE: When any or all of the bits have failed, you should perform the same troubleshooting steps. Make sure the procedure was performed properly. Try swapping the hall effect sensor connectors at the interconnect board to determine if the problem is the hall effect sensor. If it isn't the hall effect sensor, then the Interconnect board, 37-pin cable, and the GSP board are the other possibilities.
