# GSP9702 and GSP9712 Service Manual

**HUNTER**  
*Engineering Company*

This manual will assist service personnel in repairing and troubleshooting the GSP9700 Series (GSP9702 and GSP9712) Vibration Control System.

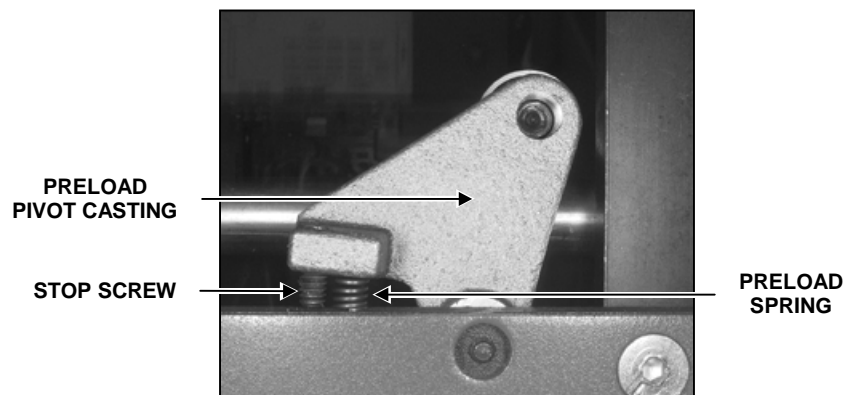
The inner Dataset® arm should glide freely in the grooves of the rollers along its track with a little vertical movement at the base. If it does not glide freely and seems to be binding, verify that the shaft is not marred or bent. If the preload pivot casting is putting too much pressure on the shaft, check that the stop screw is adjusted properly. There should be a 0.010 - 0.020 inch gap under the stop screw. If there is too much movement, rotate the adjustment screw clockwise to tighten the adjustment. The arm should glide freely along the track under the pressure of the spring.

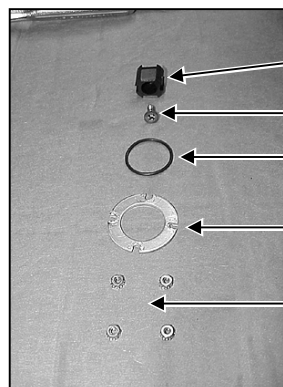
7. Remove the Phillips head screw, 75-508-2, from the magnet assembly, 176-35-1. Remove the magnet assembly.

MAGNET ASSEMBLY, 176-35-1

PHILLIPS HEAD SCREW, 75-508-2

1. Place the Phillips head screw, 75-508-2, into the magnet assembly, 176-35-1. Verify the key molded in the magnet assembly is positioned into the keyway of the shaft. Tighten the Phillips head screw.
2. Place the O-ring in the opening.
3. Place the new Hall effect sensor, 125-299-1, into the opening.
4. Place the retainer into position.
5. Replace the four nuts previously removed, 76-59-2, over the retainer, 41-112, and tighten.
6. Reconnect the sensor wire to the interconnect board, (J6 for lateral sensor, J7 for radial sensor).
7. Reconnect the power cord to the power source.
8. Calibrate the GSP9700 inner Dataset® arm.

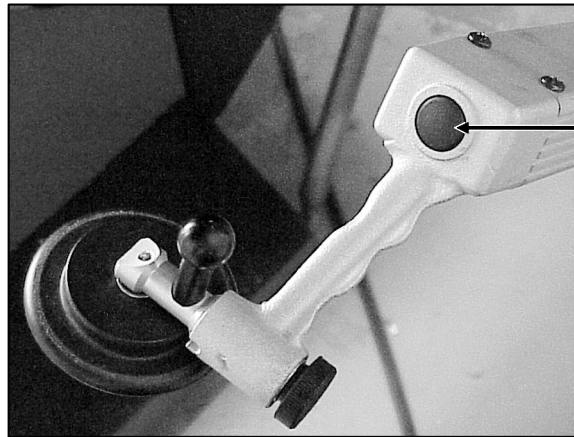
**DATASET® ARM SWITCH, 18-396-1, IS ACTIVATED BY PUSHING THIS BUTTON**

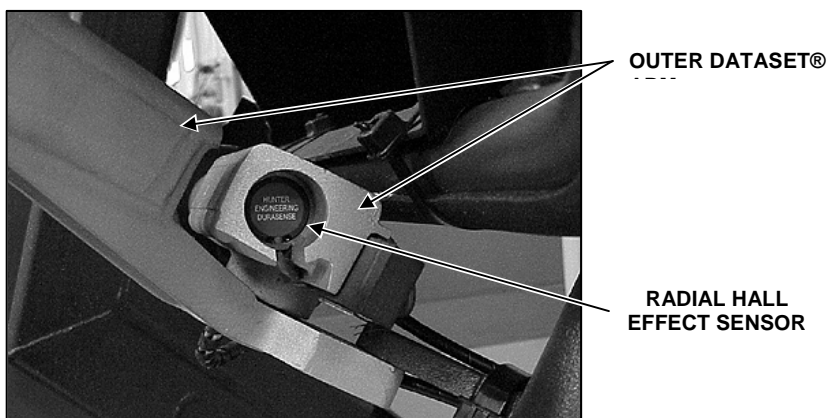
The radial Hall effect sensor is located in the “bend” of the outer Dataset® arm.

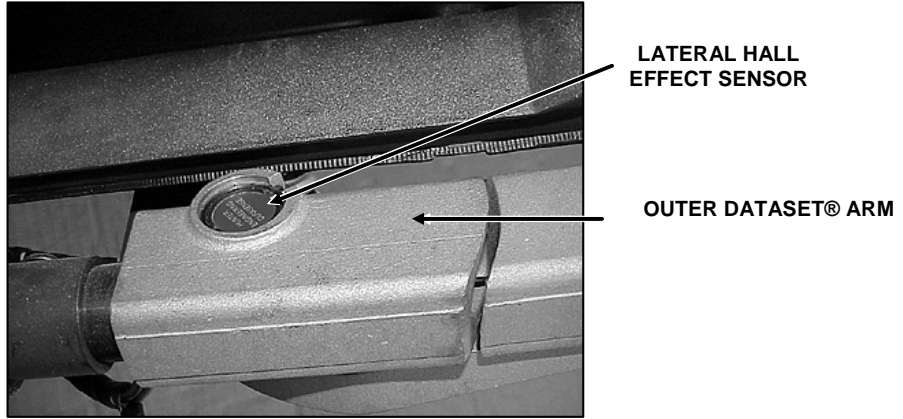
The lateral Hall effect sensor is located on the top of the outer Dataset® arm near the hood.

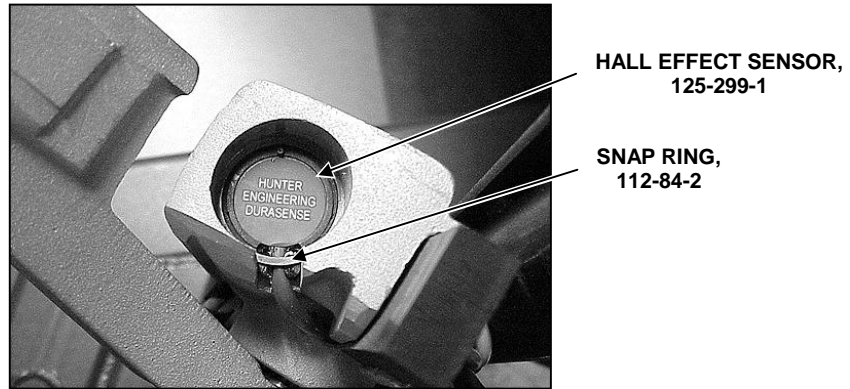
3. Remove the snap ring, 112-84-2, which is holding the Hall effect sensor, 125-299-1, in place.

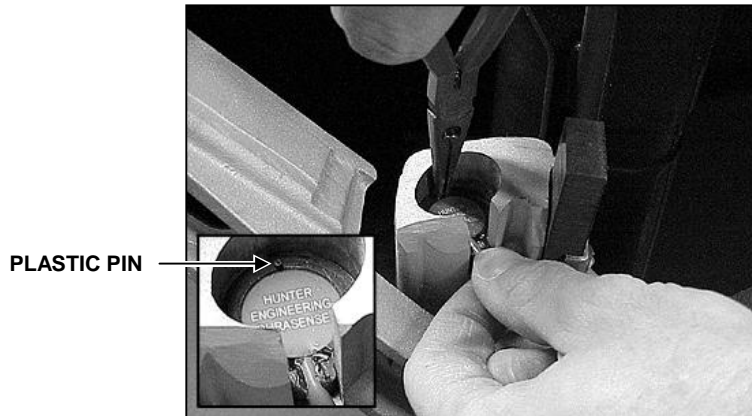
4. Remove the sensor by grasping the extruded plastic pin with needle nose pliers, while gently pulling on the sensor wire.

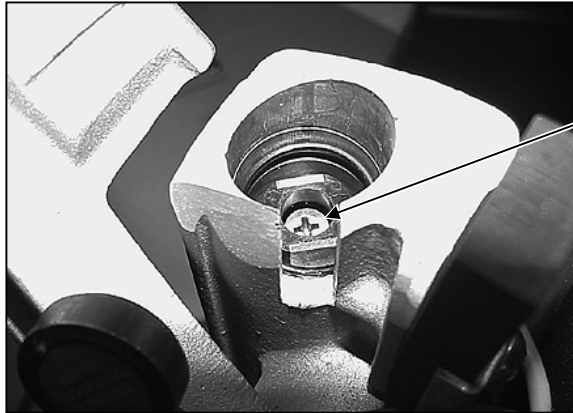
5. Remove the brass Phillips head screw, 75-508-2, from the center of the magnet assembly, 176-35-1. Remove the magnet assembly from the arm.

PHILLIPS HEAD SCREW,  
75-508-2

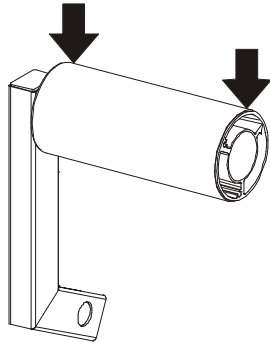
GSP9702

Check load roller for excessive runout with a dial indicator. Runout should be checked on the aluminum surface on both ends of the load roller.

Any runout detected over 0.005 inch is excessive and the load roller assembly, 111-79-1 (GSP9702) or 111-99-1 (GSP9712), should be replaced.

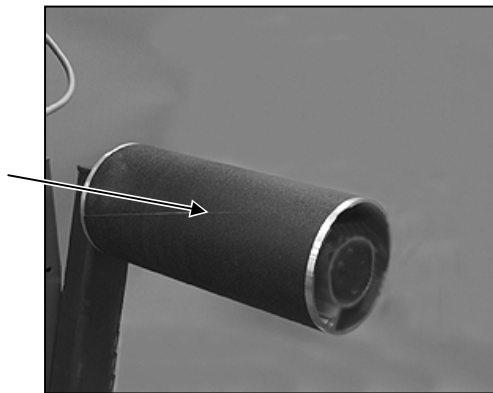
GSP9702

If the load roller does not require replacement, clean any excessive rubber build-up on the non-skid tape with a wire brush and rubber buffer. Replace non-skid tape, 162-93 (GSP9702) or 162-110 (GSP9712), if necessary. To remove the used non-skid surface, peel the adhesive surface away from the roller by pulling with pliers. Use a scraper and a rubber buffing type compound to remove any adhesive remaining on the load roller before installing new non-skid tape.

PULL ADHESIVE  
HERE

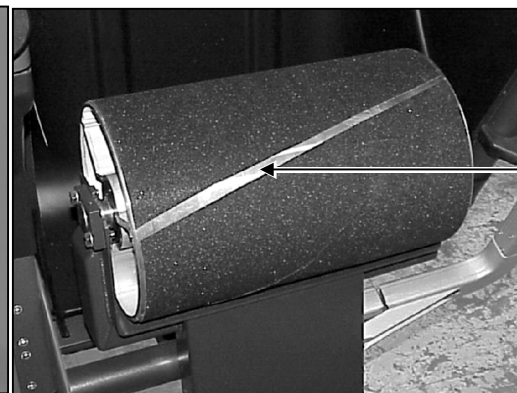
GSP9712

PULL ADHESIVE  
HERE

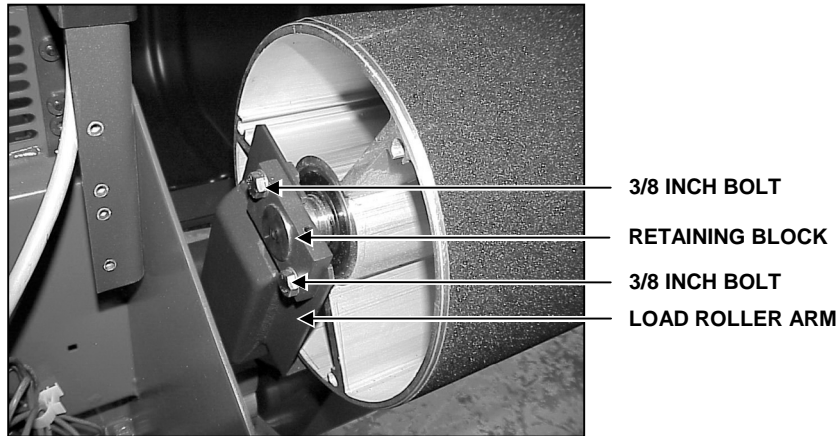
1. Disconnect the power cord from the power source.
2. Disconnect the air supply from the GSP9712.
3. Remove the two 3/8 inch bolts securing the load roller retaining block to the load roller arm.

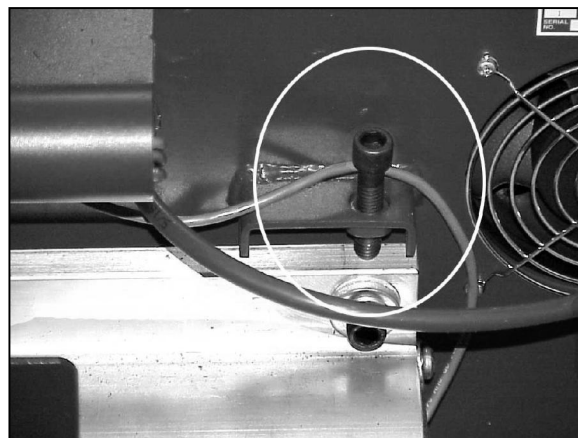
3. To adjust the load roller assembly, begin by loosening the adjustment screw above the aluminum bearing housing.

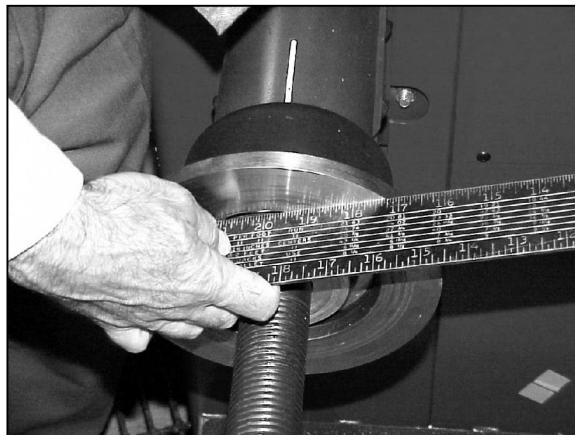
- Place the side of a carpenter's square flush against the spindle hub.

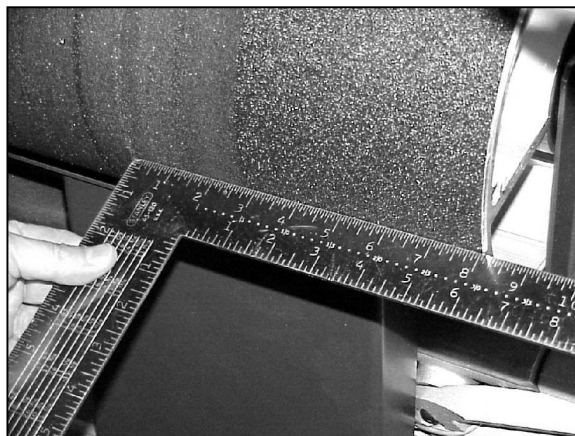
- Place the corner angle flush against the load roller.

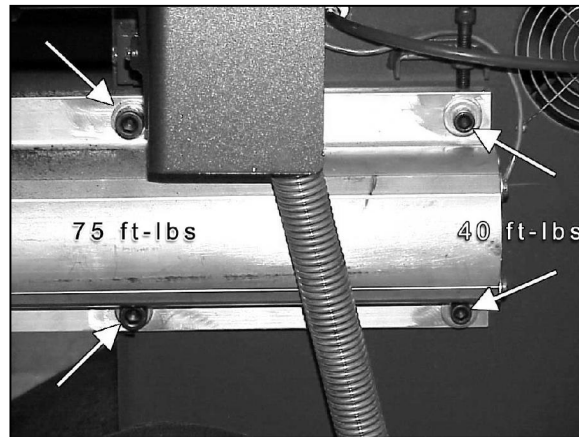
7. If the square does not sit flush or within 1/32", then adjust the angle using the spacer nuts in between the aluminum bearing housing and the cabinet. Use the open-end wrench provided with the kit. Torque the bolts as shown below with the inner two to 40 ft-lbs and the outer two to 75 ft-lbs. Recheck to make sure the load roller has not moved.

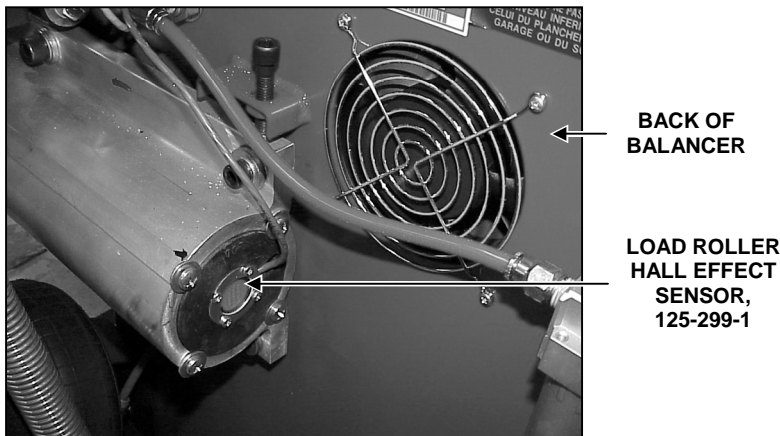
1. Disconnect the power cord from the power source.
2. Locate the Hall effect sensor.

3. Disconnect the sensor wire from the interconnect board, (J2).
4. Remove the four Phillips head screws, 75-128-2, holding the retainer, 41-112, in place.
5. Remove the retainer.
6. Remove the Hall effect sensor, 125-299-1, by grasping the extruded plastic pin with needle nose pliers, while gently pulling on the sensor wire.
7. Remove the O-ring.
8. Remove the Phillips head screw, 75-508-2, from the magnet assembly, 176-35-1. Remove the magnet assembly.

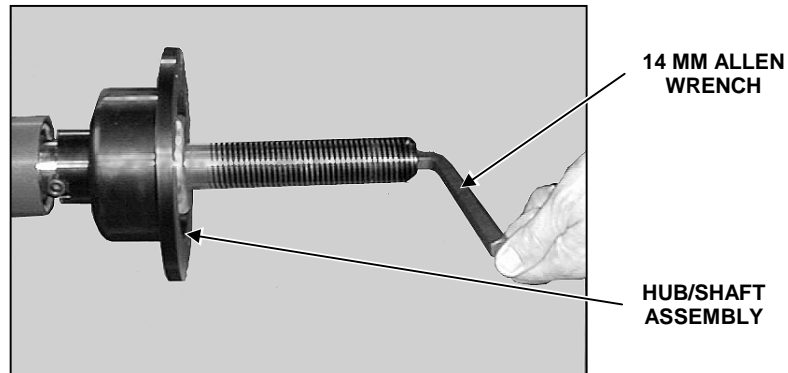
1. Remove the 14mm bolt inside of the hub shaft assembly.

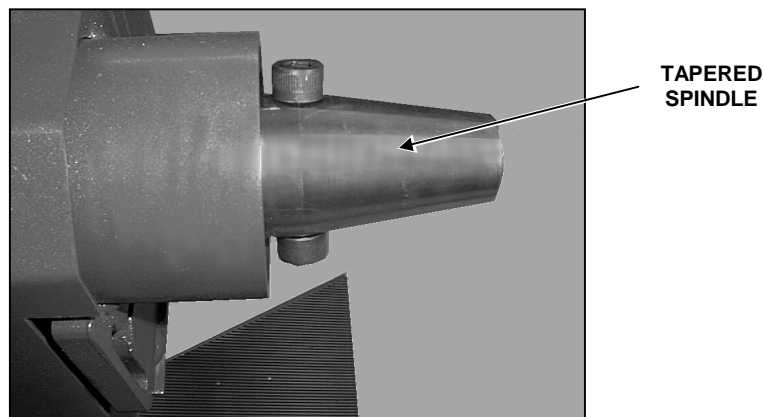
1. Clean the taper of the spindle with a clean cloth and verify that it is free of dirt, debris, and nicks. Apply a light coat of oil to the taper.

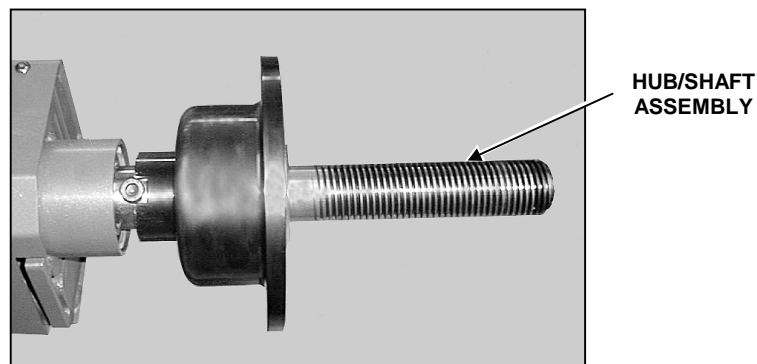
2. Position the hub/shaft assembly on the tapered surface.

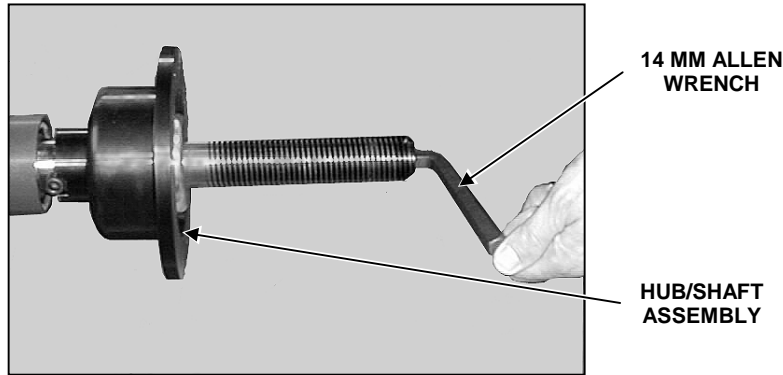
3. Seat the assembly on the tapered surface. Tighten the bolt located inside the hub/shaft assembly to approximately 50 ft-lbs.

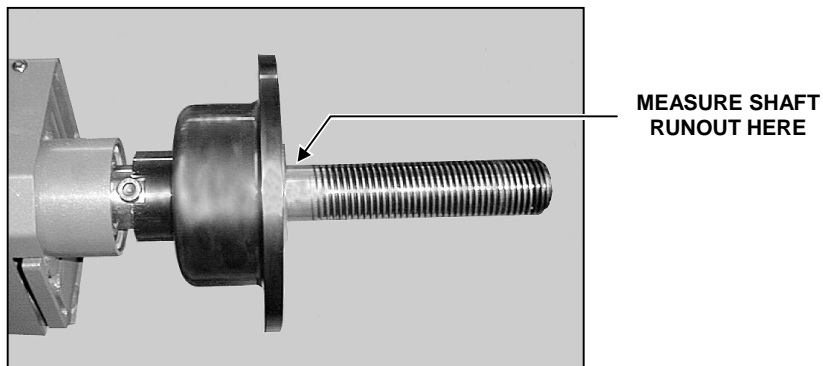
Spindle structure bolt torque: 80 ft-lbs.

Spindle pulley bolt torque: 100 ft-lbs.

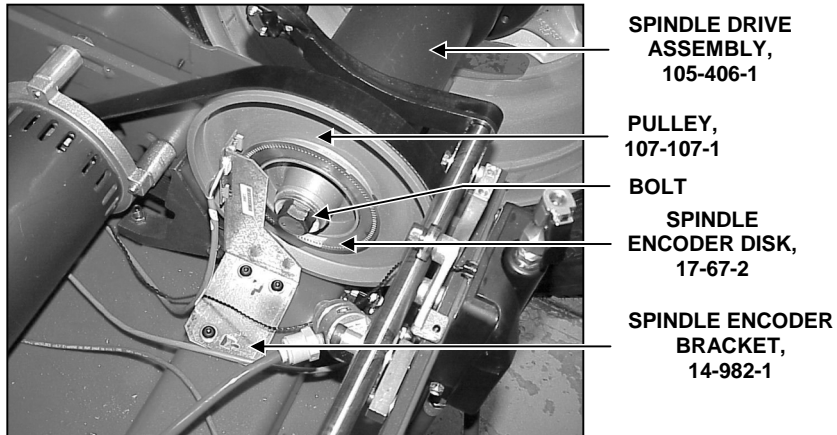
4. Remove the washer, 77-66-2, spindle encoder disk, 17-67-2, and the pulley from the taper of the spindle drive assembly.

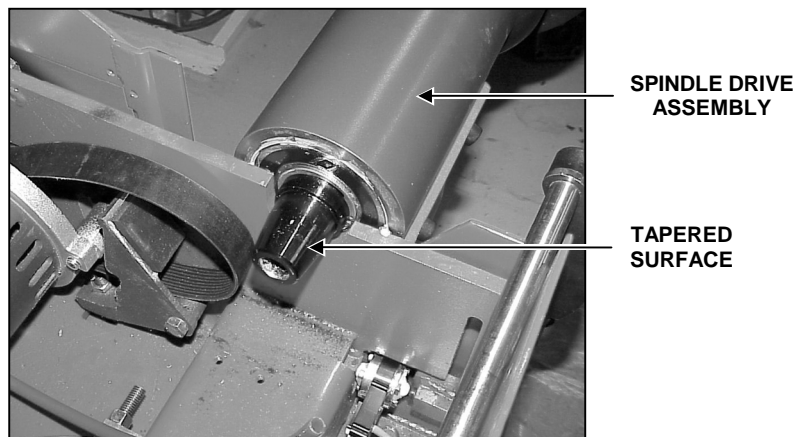
1. Clean the taper of the spindle drive assembly with a clean cloth and verify that it is free of dirt, debris, and nicks. Apply a light coat of oil to the taper.
2. Position the spindle drive assembly on the support.

3. Reinstall the four socket head cap screws previously removed, securing the spindle drive assembly to the support.
4. Slide the pulley, the spindle encoder disk, and the washer onto the tapered surface of the spindle drive assembly. Thread the bolt into the end of the spindle drive assembly. Tighten the bolt to approximately 100 ft-lbs.
5. Secure the spindle encoder bracket to the inside of the balancer with the three screws previously removed.

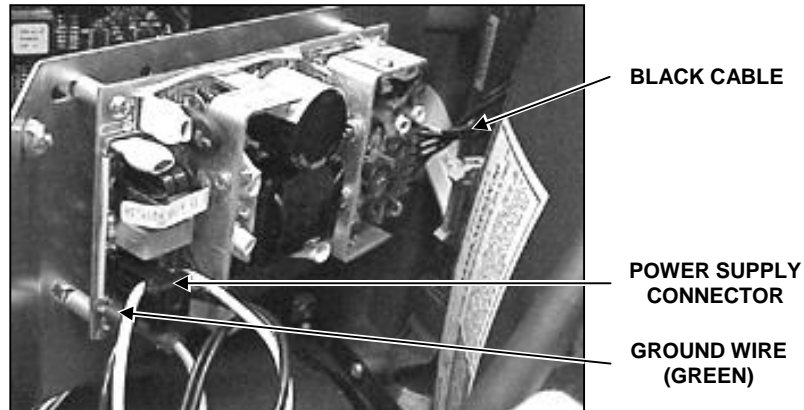
1. Disconnect the power cord from the power source.
2. Disconnect the black cable leading to the GSP Board.
3. Disconnect the AC power supply 3-pin connector.
4. Remove the green ground wire connector from the board.

5. Remove the four Phillips head screws holding the power supply board to the metal backing plate.

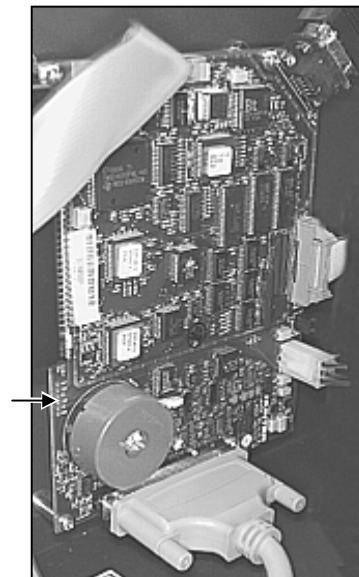
#### TEST PADS

+12  
+5A  
+5 (GENERATED ON GSP BOARD)  
-12  
-5 (-5 ANALOG, GENERATED ON GSP BOARD)  
GND (GROUND)

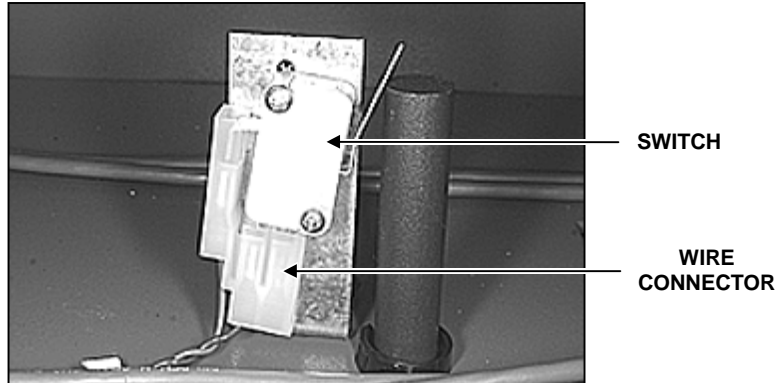
1. Disconnect the power cord from the power source.
2. Disconnect the wire connector from the switch.

3. Remove the Phillips head screws that connect the switch to the base of the GSP9700.

To adjust the foot pedal, loosen the screws at the base of the switch and move the switch closer to the foot pedal rod. Tighten the screws while holding the switch in its new position. Adjust the switch position if necessary so it switches simultaneously or just before the Spindle-Lok® pad contacts the drive pulley.

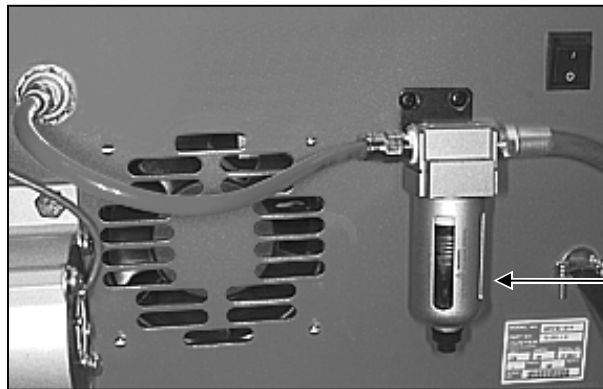
The filter element located inside the pneumatic filter on the rear of the balancer must be kept clean. Cleaning interval is dependent upon shop conditions. The filter will automatically drain water and oil out of the bottom of the filter bowl. To remove the filter element, unscrew the filter bowl from the upper filter body.

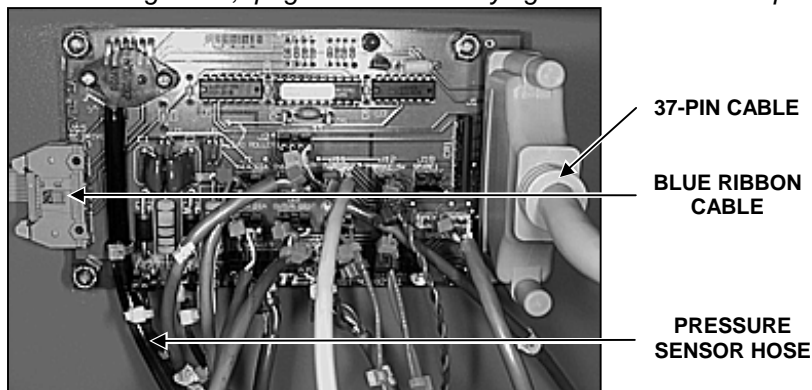
The Interconnect Printed Circuit Board assembly connects force sensors, Hall effect sensors, hood switches, and DC motor drive to the GSP Board. It also provides drive outputs for the air valves and contains an air pressure sensor.

The interconnect board is not field serviceable. Exchange all failed boards. Refer to "Troubleshooting Chart," page 4-10 for identifying interconnect board problems.

1. Disconnect the power cord from the power source.
2. Disconnect the air supply from the GSP9700.
3. Disconnect all wires from the interconnect board.
4. Disconnect the blue ribbon cable from the interconnect board.
5. Disconnect the pressure sensor hose from the four way air inlet.
6. Disconnect the 37-pin console cable from the interconnect board.
7. Remove the four nuts from the interconnect board.

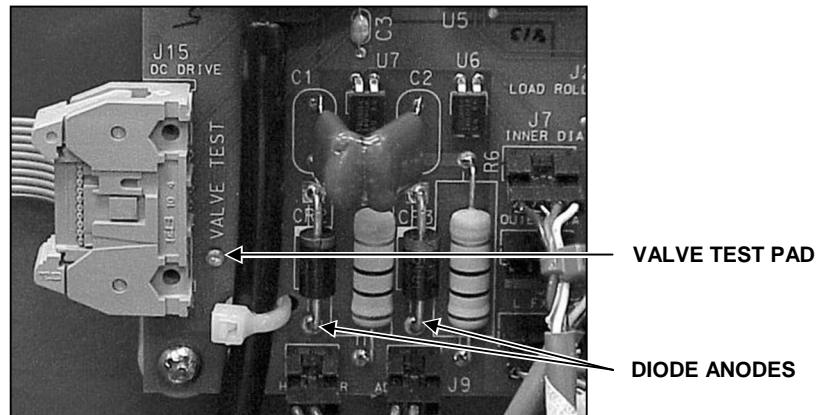
Recent interconnect boards include a test pad labeled “Valve Test.” If this pad is present, you may test a valve by connecting a jumper from the diode anode (the end without the silver band) located immediately above the connector of the valve being tested and to the “valve test” pad. The valve will turn on, if the valve being tested is not defective.

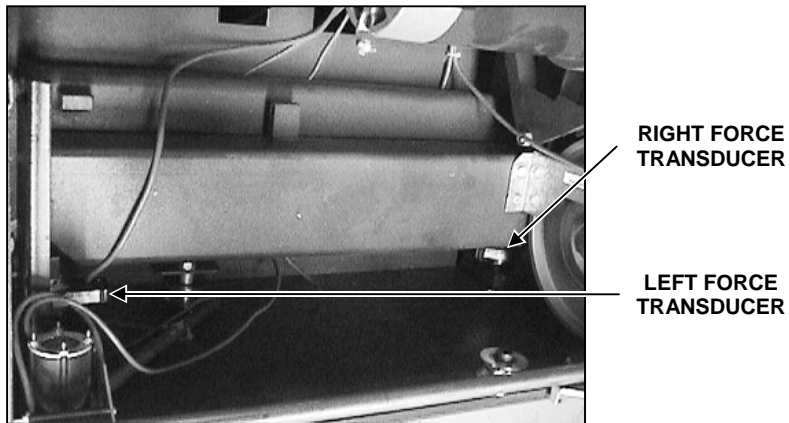
GSP9702

The Force Transducers attach to the left and right side of the balancer frame.

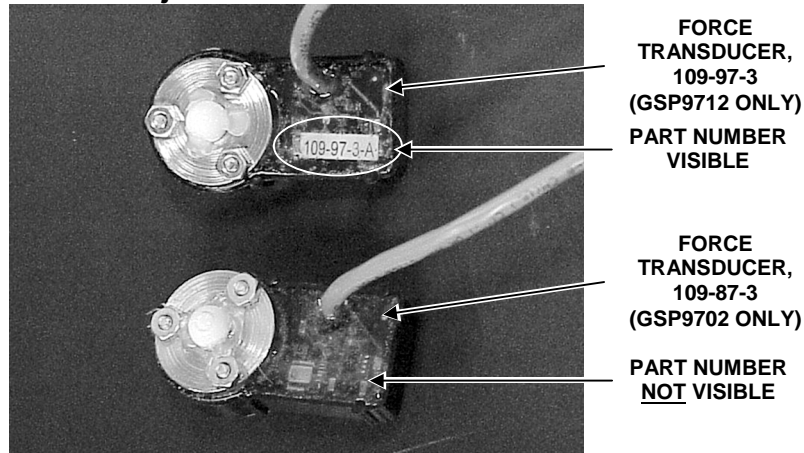
**NOTE:** Use force transducer, 109-87-3, in GSP9702 balancers only. Use force transducer, 109-97-3, in GSP9712 balancers only. The force transducers are NOT interchangeable.

Ceramic balls are glued to the transducer to aid in assembly at the factory. On early models that are not glued, the ceramic balls may be held in place with a small amount of all-purpose grease during assembly.

2. Place the right transducer in position and tighten the setscrew slowly, until the transducer holds in place with no looseness.
3. Place the left transducer in position and tighten the setscrew slowly, until the transducer holds in place with no looseness.

4. Starting with either transducer, tighten the setscrew 1/4 turn.
5. Move the transducer in small arcs to allow the ball and transducer to properly seat. Position the assembly so that the long edge of the transducer is parallel with the floor (excessive angle will cause the transducer to contact the structure, upsetting the imbalance vibration readings). Repeat this procedure for the second transducer.
6. On the first transducer, tighten the setscrew another 1/4 turn, then tighten the setscrew on the second transducer another 1/4 turn.
7. Reconnect the left force transducer to J13 on the interconnect board.
8. Reconnect the right force transducer to J14 on the interconnect board.
9. Recalibrate the GSP9700. (3-spin cal procedure)

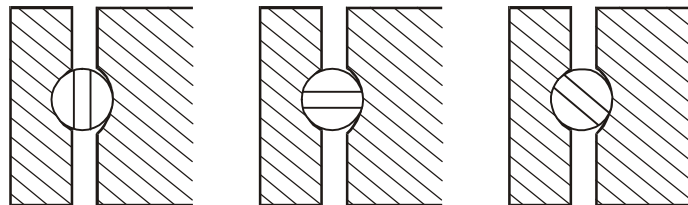
1. Clean the mounting surfaces so that the ball sockets and ceramic balls are completely free of any dirt or debris. Install the new transducer, making sure that the flat surface area of the ball is not contacting the ball seat. Note that later production balls do not have a flat around the middle.

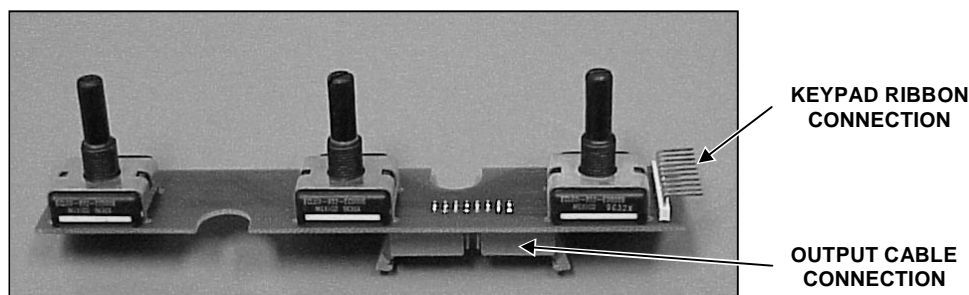
The knobs board combines the knob encoder signals and keypad signals into one cable output to the GSP Board. The knobs board receives the signals from the keypad, 18-383-2, through the keypad ribbon cable connected to the end of the knobs board.

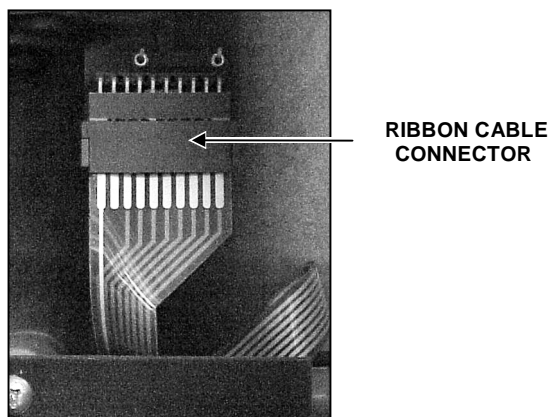
It is important to observe the direction of attachment during removal. The keypad cable is notched on one side, however will attach in either direction. For proper operation, the cable **must** be reattached in the direction as shown below.

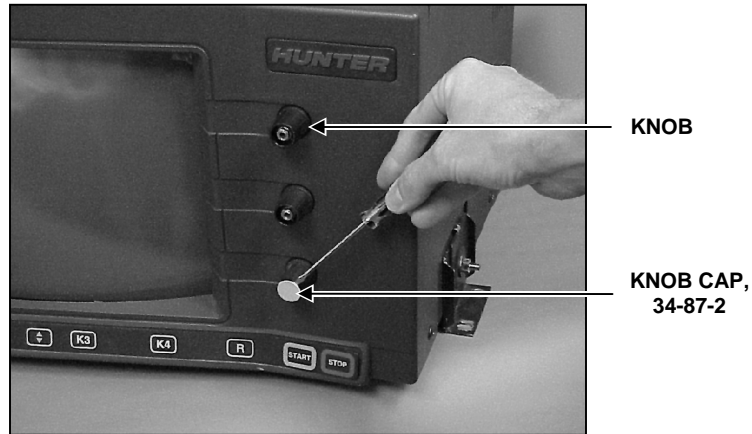
5. Remove three knob caps, 34-87-2, from the knobs by inserting a thin screwdriver between the knob and cap and then gently prying the cap off the knob.

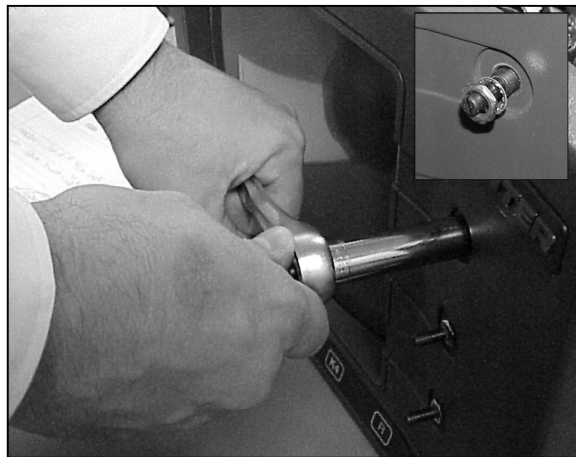
7. Remove the inner knob nut by turning the nut counterclockwise. After the nut is removed, remove the inner washer from the knob spindle. Repeat for the two remaining knobs.

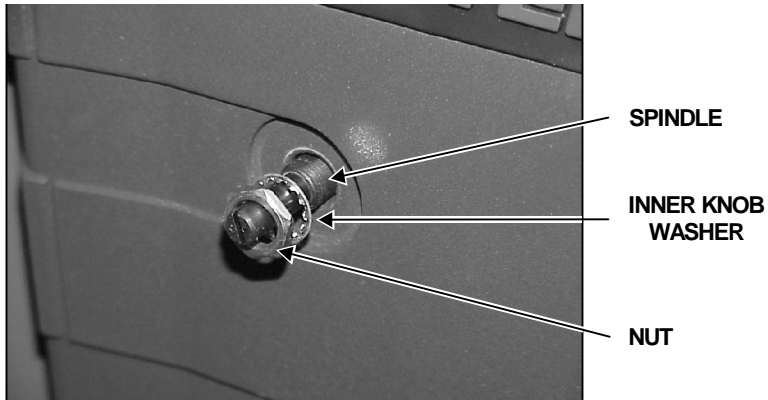
2. Place the inner knob washer on the knob spindle. Place the nut on the knob spindle. Gently tighten the nut by turning it clockwise, being careful to not overtighten the nut on the plastic threads. Repeat for the two remaining knobs.

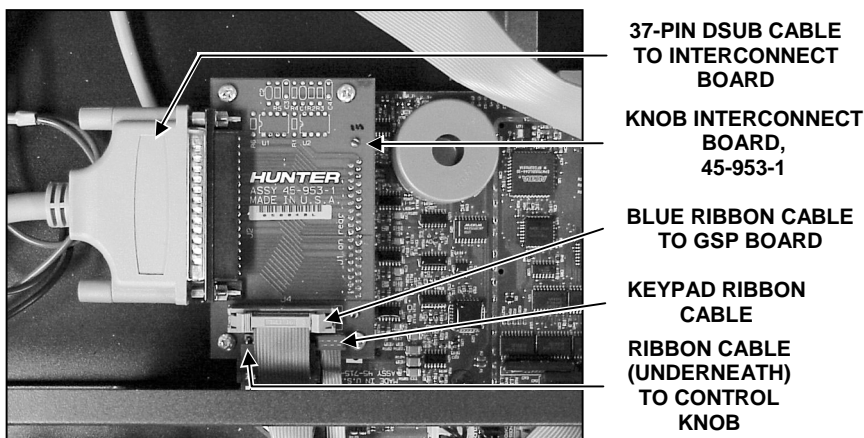
1. Disconnect the power cord from the power source.
2. Remove the monitor and the top cover from the CRT support console.
3. Disconnect the blue ribbon cable from J4 of the knob interconnect board.

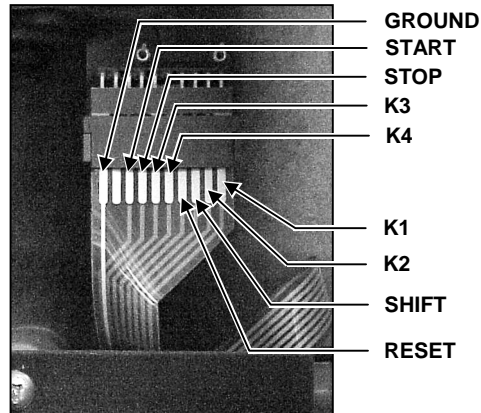
It is important to observe the direction of attachment during removal. The keypad cable is notched on one side, however will attach in either direction. For proper operation, the cable **must** be reattached in the direction as shown below.

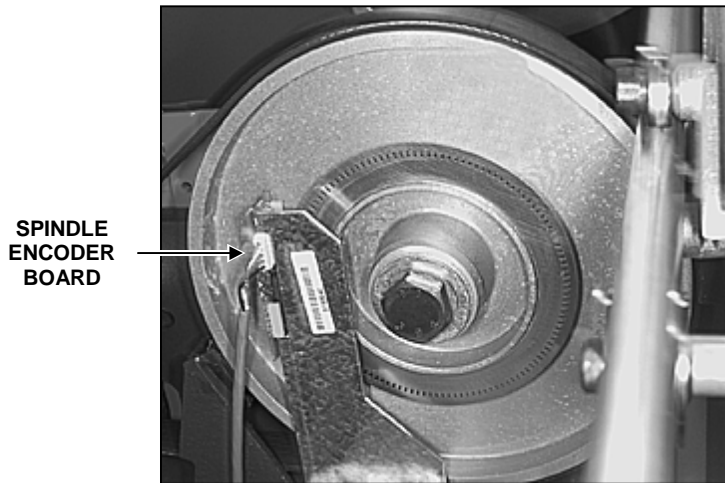
There are three LED's on the spindle encoder. These LED's signal that the opto-interruptors on the LED board are working as the spindle is turning.

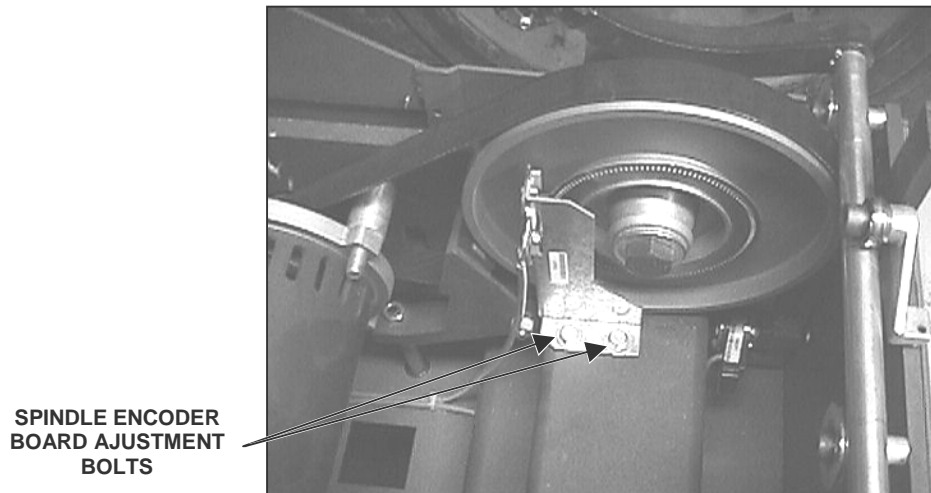
1. Locate the spindle encoder board adjustment bolts.

2. Loosen the adjustment bolts and adjust the spindle encoder board so that it is centered and has a 1/32 inch to 1/16 inch gap at the back of the board.

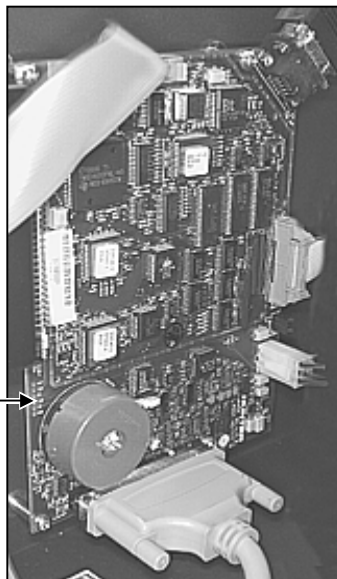
### TEST PADS

The GSP board controls operation of the entire GSP9700 Series Vibration Control System. Static sensitive components on the GSP board can easily be damaged if anti-static precautions are not observed while you are working inside the console. The GSP board is a printed circuit board that interfaces with the interconnect board, printer port, program cartridge, power supply, and CRT port. A 25 watt power supply in the console provides +5v and  $\pm 12$ v inputs. The +12v drives the air valves and beeper, while the  $\pm 12$  feed the  $\pm 5$ v analog voltage regulators on the GSP board. The  $\pm 5$ v analog powers the data acquisition circuits on the GSP board. To verify a voltage, use the power supply test pads on the GSP board.

+12  
 +5A  
 +5 (GENERATED ON GSP BOARD)  
 -12  
 -5 (-5 ANALOG, GENERATED ON GSP BOARD)  
 GND (GROUND)

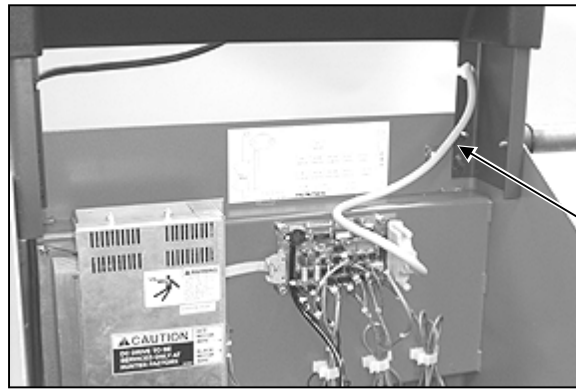
37-PIN DSUB  
DATA CABLE

12. Remove data cable and power cord from CRT support risers.

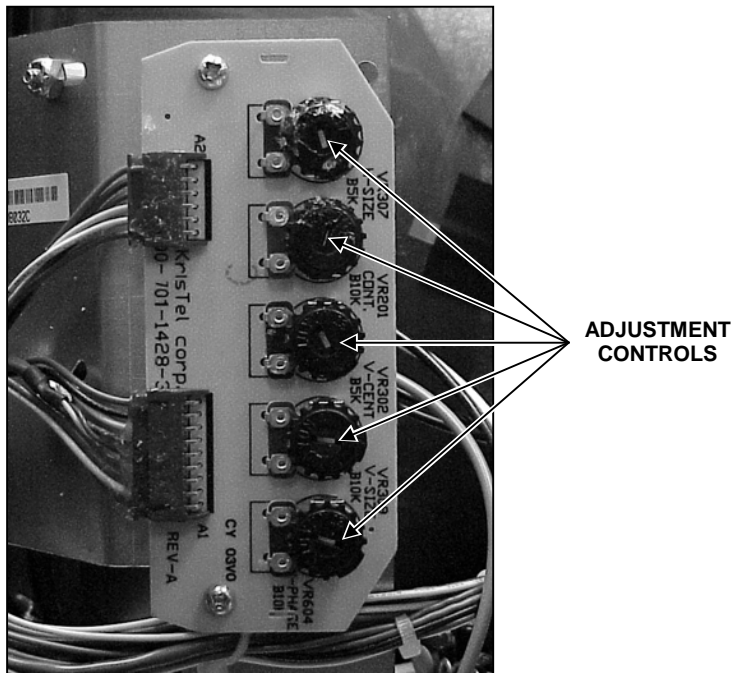
1. Remove two screws, 75-312-2, securing the access panel to the rear of the CRT assembly, 30-330-1. Lift up or remove the access panel.
2. Locate adjustment controls inside of the CRT assembly.

3. Adjust the display as needed, using the controls.
4. Replace the access panel or return it to the installed position.
5. Check the CRT for accurate video display.
6. Secure CRT access panel with previously removed screws.

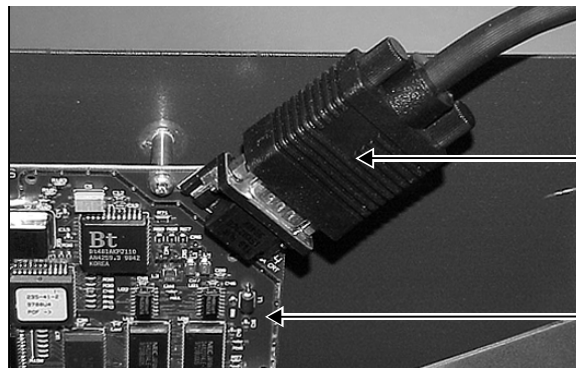
6. Disconnect the video harness from the GSP Board.

**VIDEO HARNESS**

**GSP BOARD**

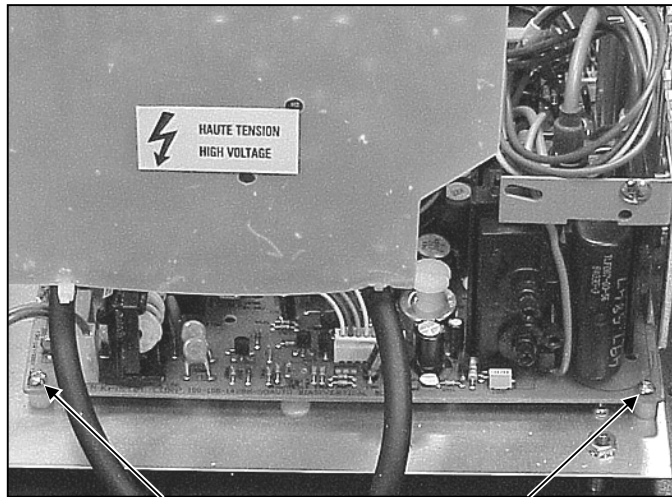
7. Remove the two screws that hold the CRT board to the CRT mounting plate on the bottom of the console.

**CRT BOARD SCREWS**

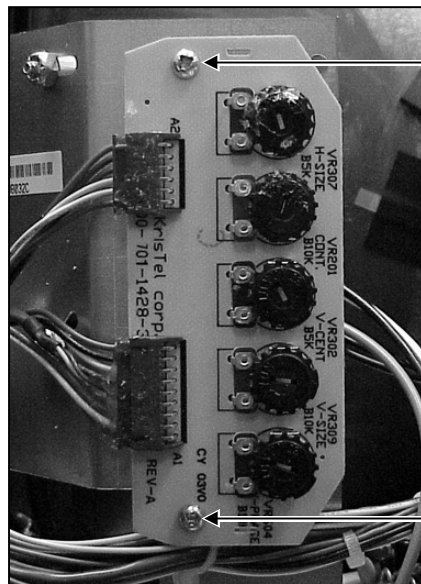
8. Remove the two Phillips head screws from the CRT potentiometer adjustment board.

**PHILLIPS HEAD SCREW**

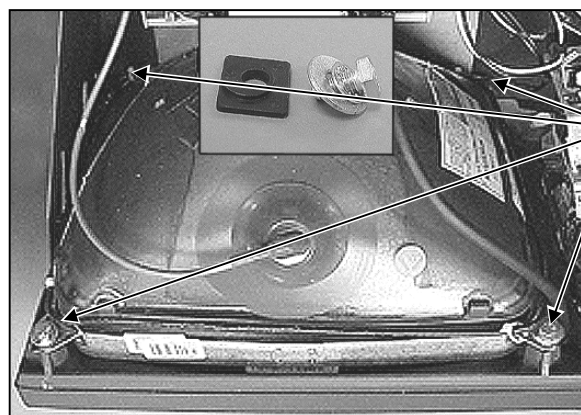
9. Remove the four bolts from the corners of the CRT.

**BOLT**

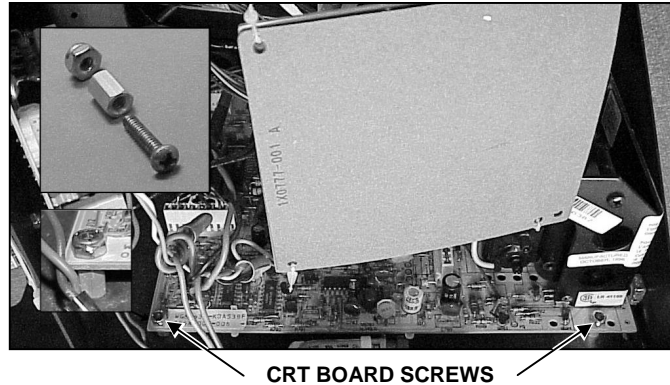
5. Remove the two screws that secure the CRT board to the bottom of the console. To remove these screws, it will be necessary to hold the nut on the CRT board with a 5/16 inch socket while turning the screw. When the screw and nut are disassembled, remove the nut, and take hold of the metal spacer before removing the screw from the bottom of the console.

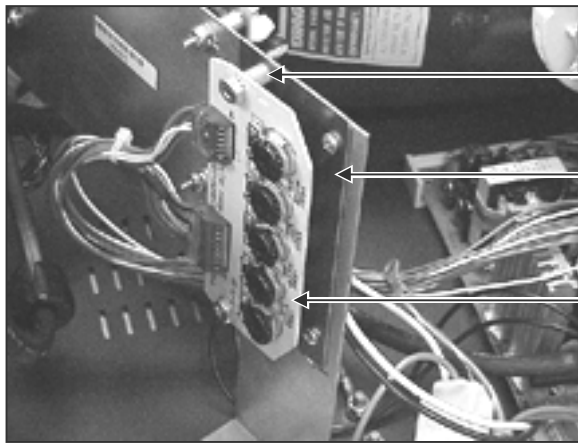
10. Secure CRT to console with four screws previously removed.
11. Install new 5/16 inch spacer, 46-328-2, between console and CRT board at hole that was previously enlarged.
12. Secure CRT board to console with screw previously removed, flat washer, 77-17-2, and grip nut previously removed.
13. Position original spacer between CRT board and console at left-side mounting hole. Secure CRT board to console with screw and grip nut previously removed.
14. Install Kristel monitor plate assembly, 51-1699-1, to the location from which the potentiometer adjustment board was previously removed.
15. Position two receiver board spacers, 46-346-2, between Kristel monitor plate assembly and potentiometer adjustment board. Secure potentiometer adjustment board to Kristel monitor plate assembly with two screws and grip nuts previously removed.

RECEIVER BOARD  
SPACER,  
46-346-2

KRISTEL MONITOR  
PLATE ASSEMBLY,  
51-1699-1

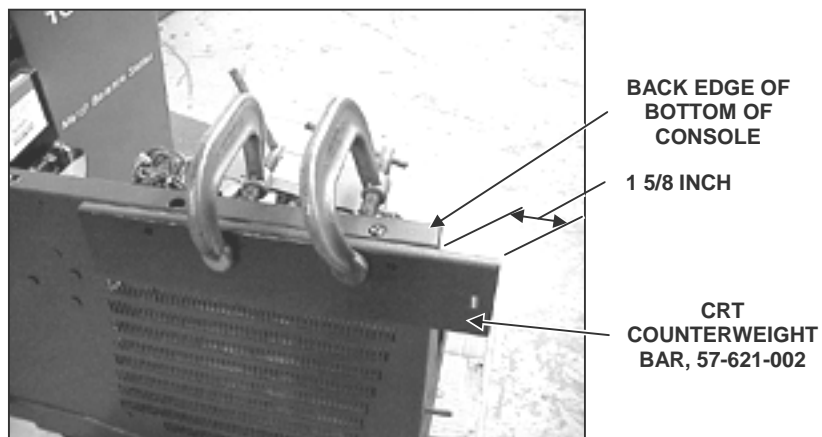
- Remove top cover from console.
- Position CRT counterweight bar, 57-621-002, on bottom of console, flush with the back of the console and protruding 1 5/8 inch to the right, as looking at the back of the console.

**NOTE:** Mounting holes in the CRT counterweight bar should be toward the back of the console.

- Clamp CRT counterweight bar, 57-621-002, to console with two C-clamps.

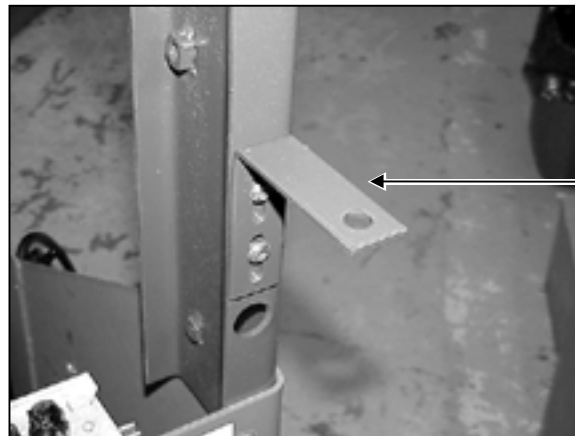
**REAR CRT SHOCK  
SUPPORT BRACKET,  
14-888-2**

16. Secure rear CRT shock support bracket, 14-888-002, to the right-hand (as facing the rear of the machine) CRT support riser assembly with two 1/4-20 x 0.50 SBHCS, 75-481-2.

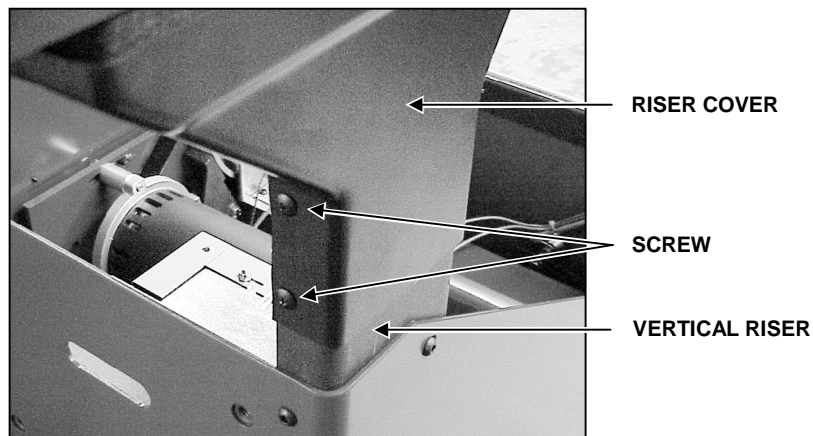
1. Remove weight tray.
2. Remove four screws securing riser cover to left riser. Repeat for right side riser.

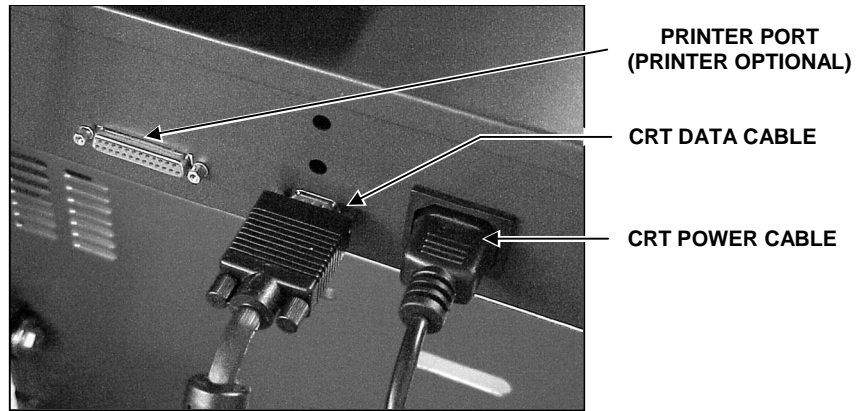
3. Disconnect the CRT data cable from the console.

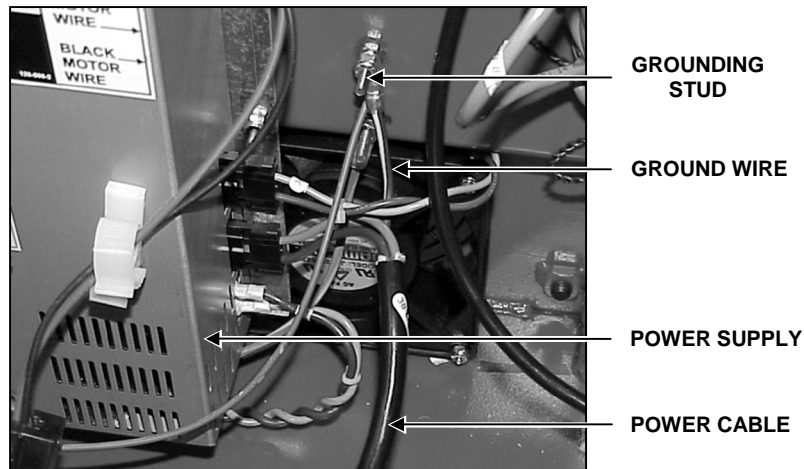
9. Disconnect the ground wire from the grounding stud located on the inside back of the base assembly. Unplug the two wires from the power supply.

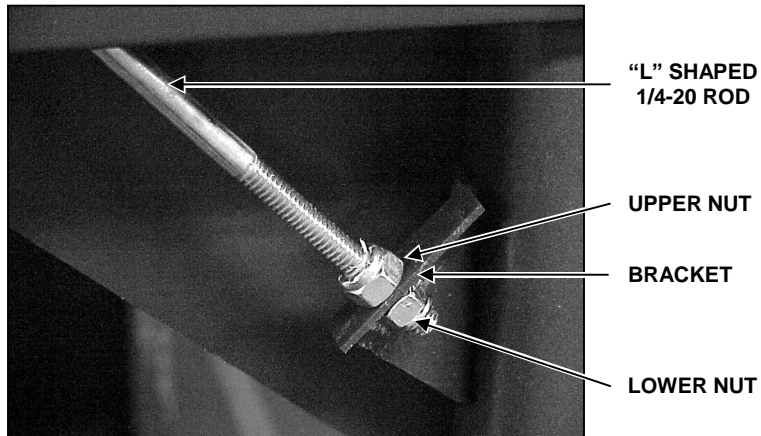
11. Remove the lower nut on the "L" shaped 1/4-20 rod. Repeat for the other vertical riser.

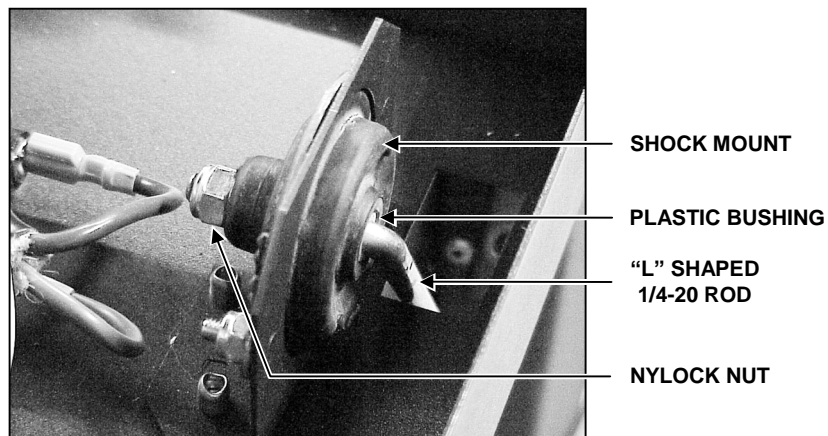
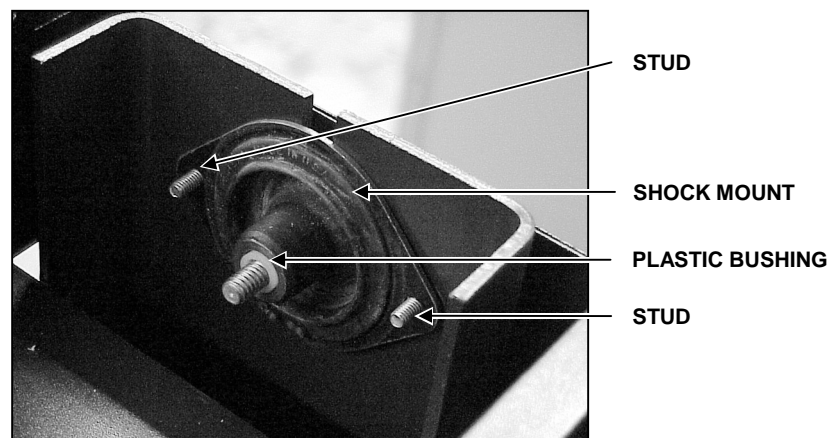
13. Remove the Nylock nuts from the two small studs and the attaching stud of the vertical riser. Remove the shock mount and the plastic bushing. Repeat for the other vertical riser.

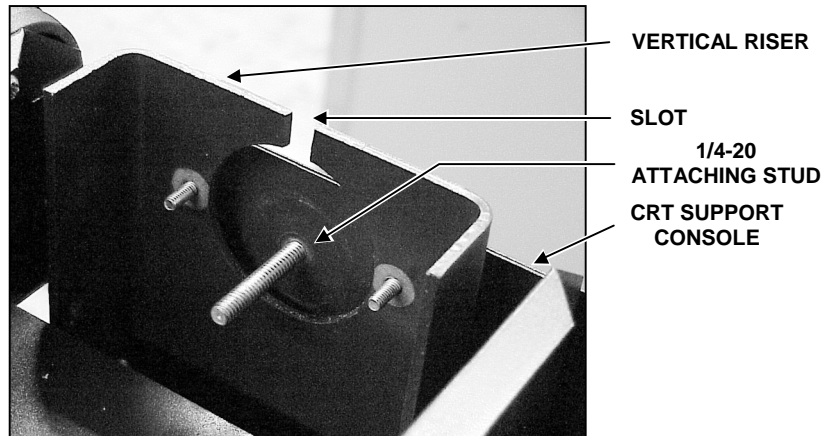
14. Lift the CRT support console from the vertical risers. The 1/4-20 attaching stud of the CRT support console should slide through the slot on the top of the vertical risers.

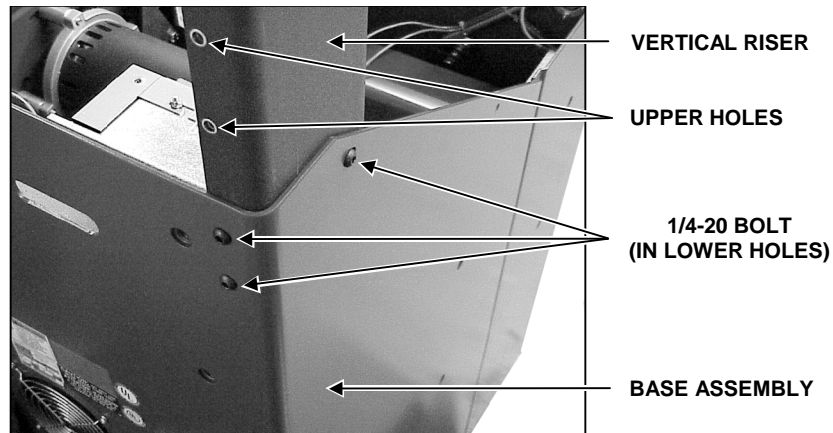
15. Remove three 1/4-20 bolts securing one vertical riser of the CRT support to the base assembly. Repeat for the other vertical riser.
