# GSP9702 and GSP9712 Service Manual

**HUNTER**  
*Engineering Company*

This manual will assist service personnel in repairing and troubleshooting the GSP9700 Series (GSP9702 and GSP9712) Vibration Control System.

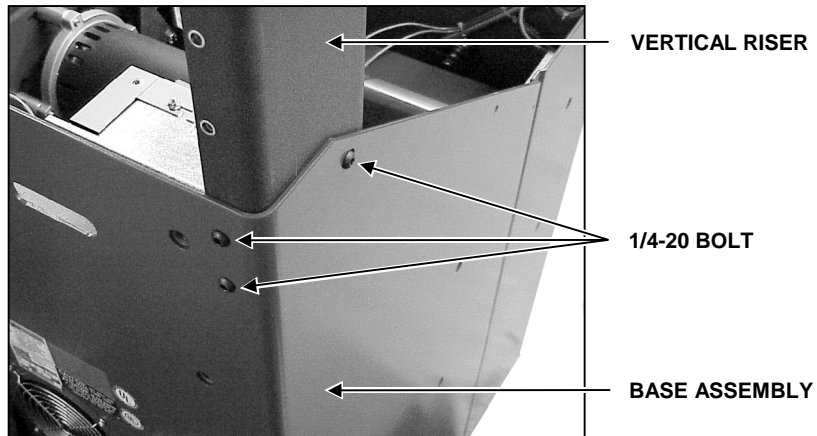
1. Secure one vertical riser of the CRT support to the base assembly with three 1/4-20 bolts. Two of the bolts thread into the rear of the base assembly and the third threads into the side. Repeat the procedure for the other vertical riser.

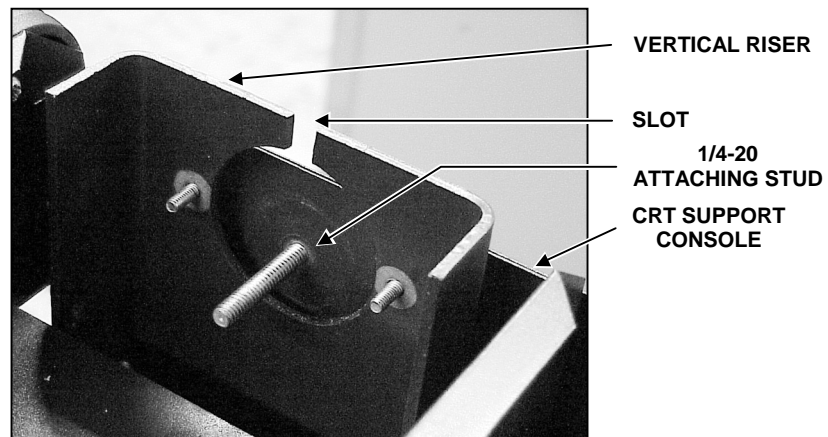
2. Remove the top cover from the CRT support console by removing four #10 Truss head screws (two from each side).
3. Slide the CRT support console down over the vertical risers. The 1/4-20 attaching stud of the CRT support console should slide into the slot on the top of the risers.

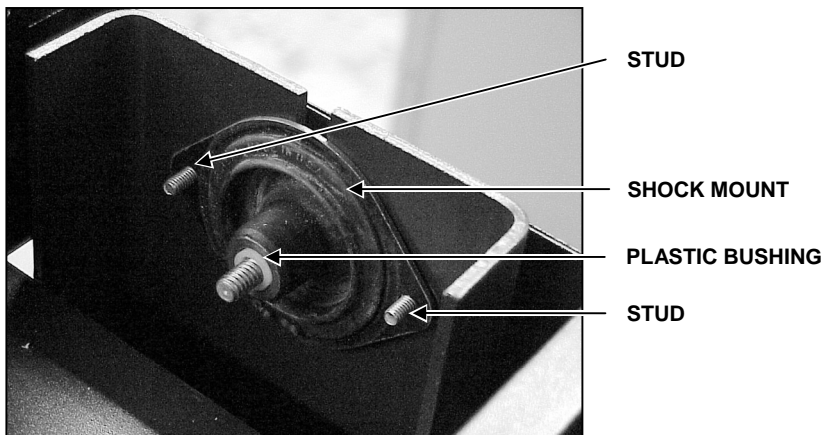
4. Slide a plastic bushing, and then the shock mount over the attaching stud and onto two studs that are pressed into the vertical riser. Secure with Nylock nuts. Repeat the procedure for the other vertical riser.

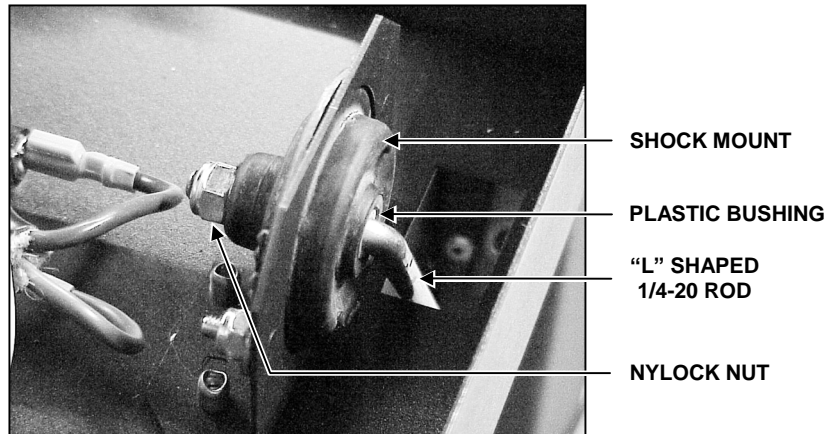
5. Position the "L" shaped 1/4-20 rod so that the long end will pass through the opening in the bottom of the CRT support console. Insert the short end of the "L" shaped 1/4-20 rod into the rear shock mount. Install a plastic bushing, and then secure with Nylock nuts. Repeat the procedure for the other rear shock mount.

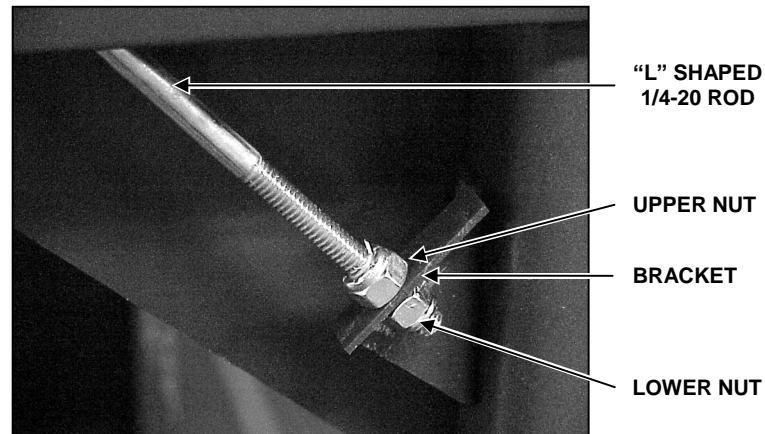
6. Remove one nut from the long end of the "L" shaped 1/4-20 rod and insert the rod into the bracket on the vertical riser. Reinstall the nut previously removed from the long end of the "L" shaped 1/4-20 rod, but do not tighten completely.

7. Level the support front to rear and side to side by loosening or tightening the upper nut on the long end of the "L" shaped 1/4-20 rod on each side.
8. When level is achieved, tighten the lower nut on the "L" shaped 1/4-20 rod.

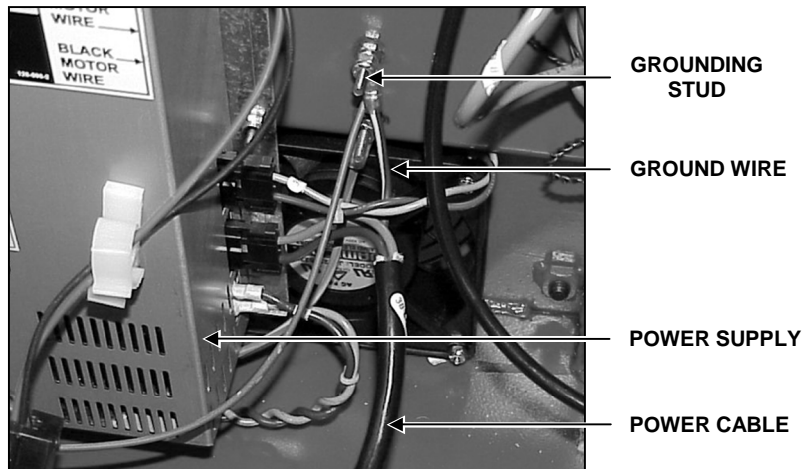
9. Route the black power cable down through the left side riser and underneath the power supply. Plug the two wires into the power supply and connect the ground wire to the grounding stud located on the inside back of the base assembly.

**NOTE:** Keep black cable and motor cord separated to minimize EMI noise on CRT display.

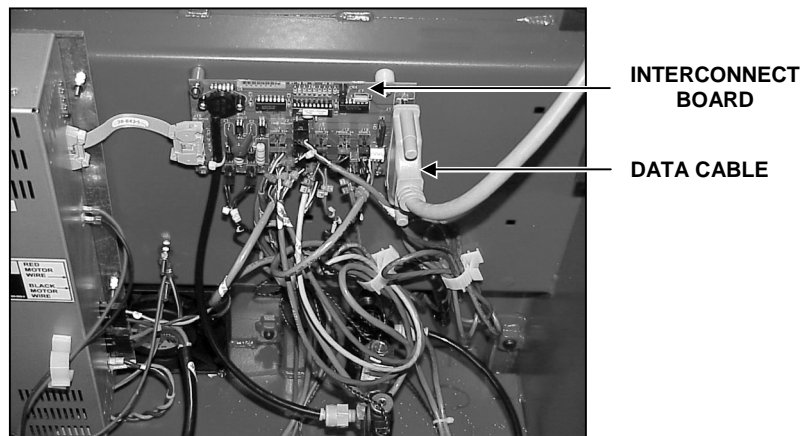
10. Route the data cable down through the right side riser. Plug the data cable into the interconnect board.

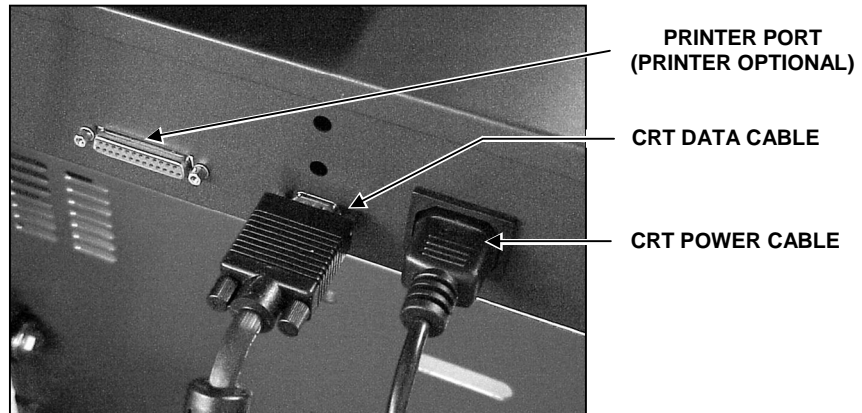
15. Connect the CRT power cable to the CRT and the console. Connect the CRT data cable to the console.

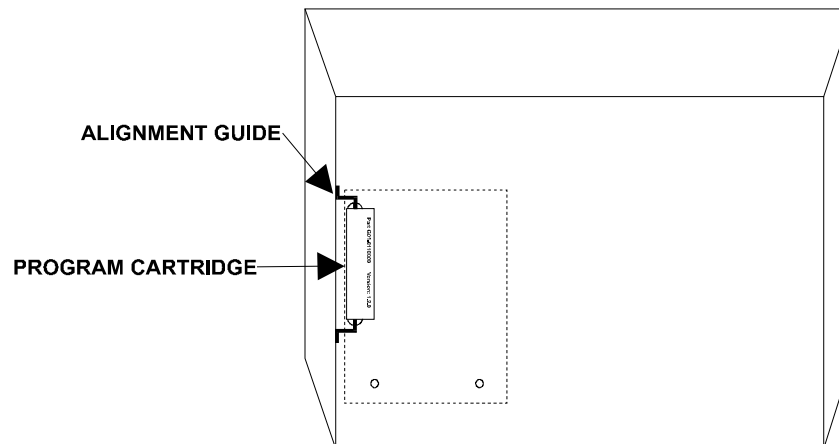
1. Verify the unit power is off and the AC power cord is disconnected from the power source.
2. Remove the two Phillips screws securing the access panel to the rear of the console.
3. Raise the access panel.
4. Remove the installed program cartridge from the CRT console.
5. Insert the new program cartridge into the console. Ensure proper alignment of the cartridge guides with the console alignment guides.

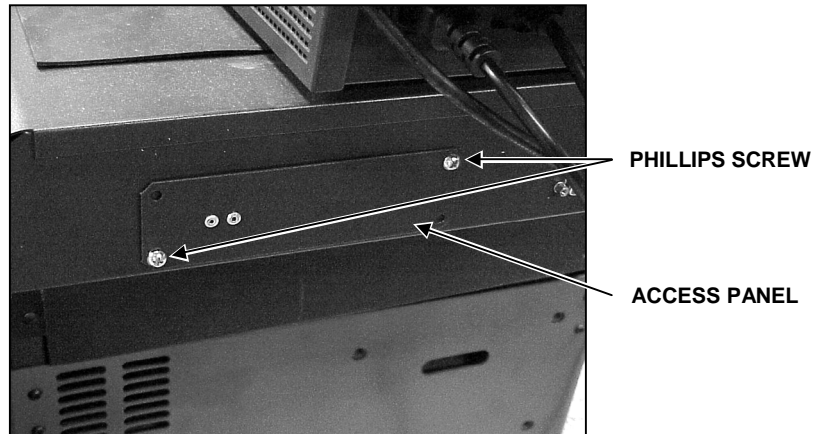
1. Verify the unit power is off and the AC power cord is disconnected from the power source.
2. Remove the two Phillips screws securing the access panel to the rear of the console.

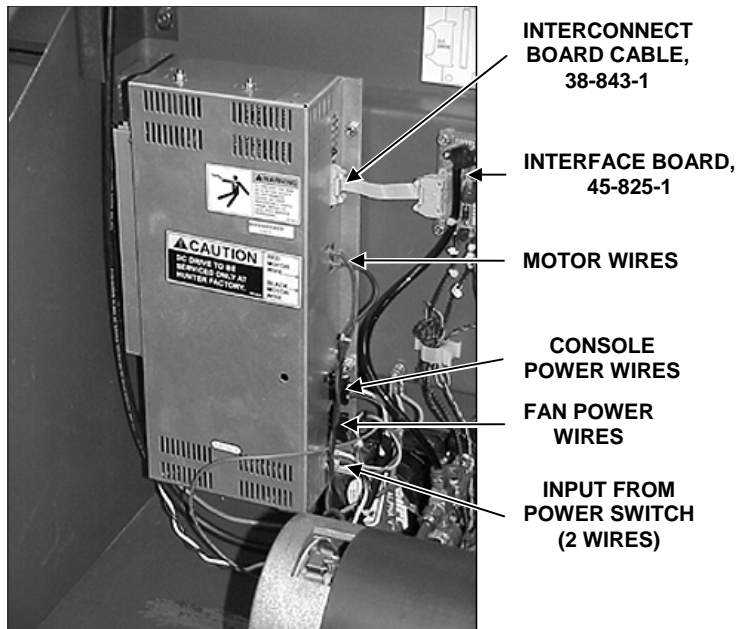
1. Unplug power cord from the power source.
2. Disconnect the interconnect board cable, 38-843-1, from the DC Motor Drive.
3. Disconnect the motor wires from the DC Motor Drive.
4. Disconnect the fan and upper console power supply from the DC Motor Drive.
5. Disconnect the power wires from the DC Motor Drive.

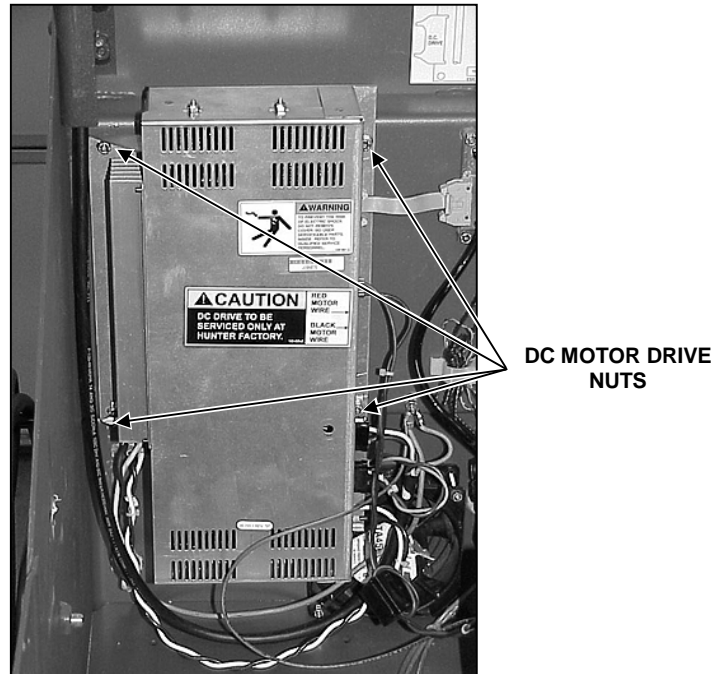
6. Remove the four nuts that secure the DC Motor Drive to the base of the GSP9700.

1. Align DC Motor Drive bolt holes with bolts in base. Secure with four nuts previously removed. Tighten nuts to 25 ft-lbs.
2. Reconnect the fan and upper console power wires to the DC Motor Drive. (Locations are interchangeable.)

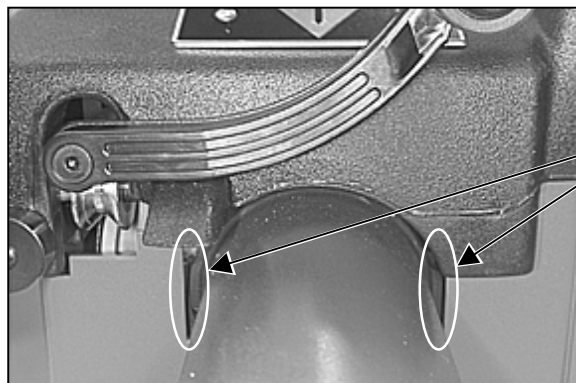
**LOOK FOR  
PROPER  
CLEARANCE IN  
THESE AREAS**

The spindle structure should only contact the cabinet at the mounting points. Stray wheel weights, nuts, bolts, etc. can wedge under the spindle structure and reduce the transfer of vibration to the transducers. An indication of this condition would be sensor output display plots that are close to equal in magnitude for the left and right sides after spinning with the calibration weight.

Repeatability concerns may be experienced if the belt tension adjusting cam bolt is rubbing on the access cover. Symptoms of force transducer problems will most likely be a complaint of chasing weights or a calibration problem/failure when attempting balancer calibration.

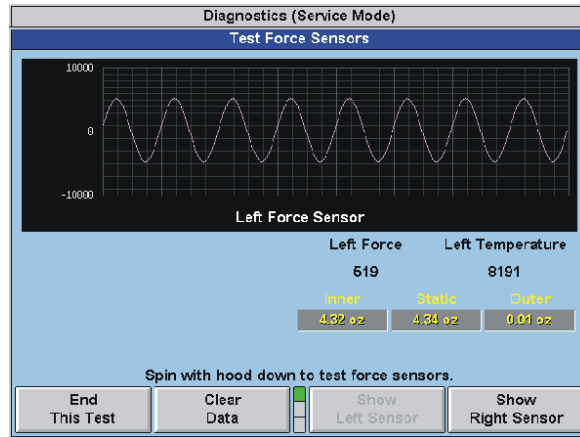
Sensor data is shown in counts. If a spin was previously performed in balance mode, eight revolutions of data will be shown.

When sensor counts are numbered 8191, clipping is occurring and/or the sensor is not reading.

On this screen, there is a force value and a temperature value. The force value should be approximately  $0 \pm 100$  and will change momentarily if pressure is applied to the spindle. The temperature value is going to vary depending upon ambient temperature, but it should be approximately 700-900. Left or right sensors (transducers) can be selected from this screen.

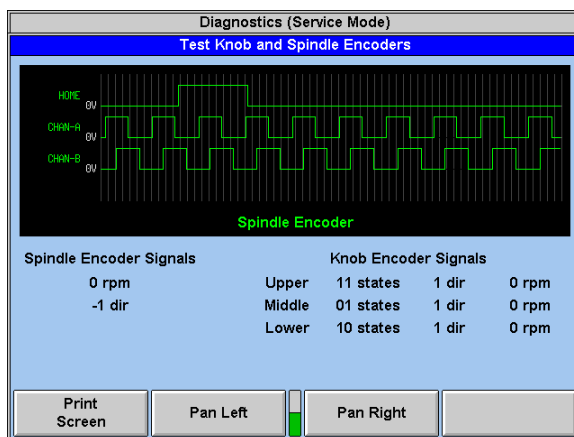
From the "Test Knob and Spindle Encoders" popup screen, select "Take Readings" while turning the spindle.

The home pulse should encapsulate 1.5 waves of Channel "A" as shown above.

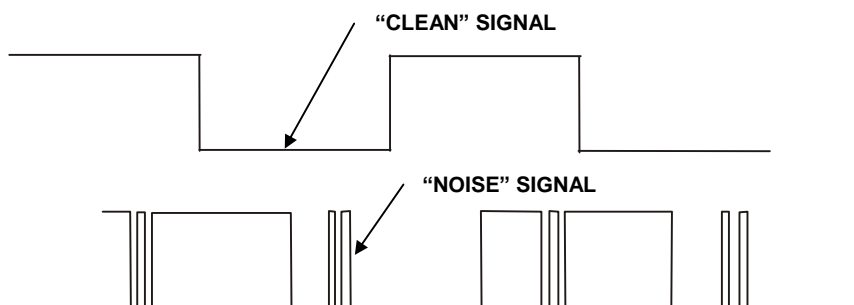
Turn the spindle and verify that there is no noise on the signals:

Turning the spindle clockwise will be displayed as a "positive 1" direction, counterclockwise will be displayed as a "negative 1" direction. Another indication of noise is if the display fluctuates between negative and positive 1, while turning the spindle in a constant direction.

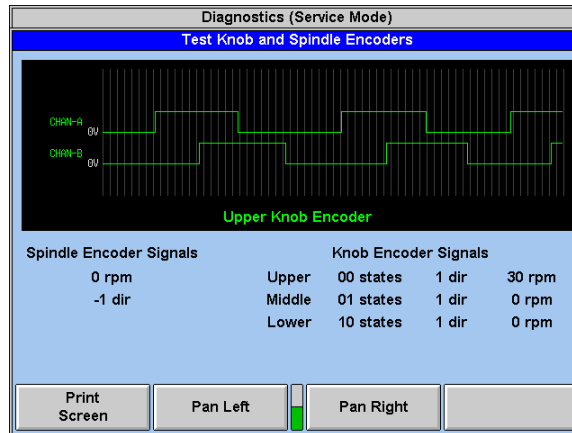
Select "Take Readings" while turning the selected knob.

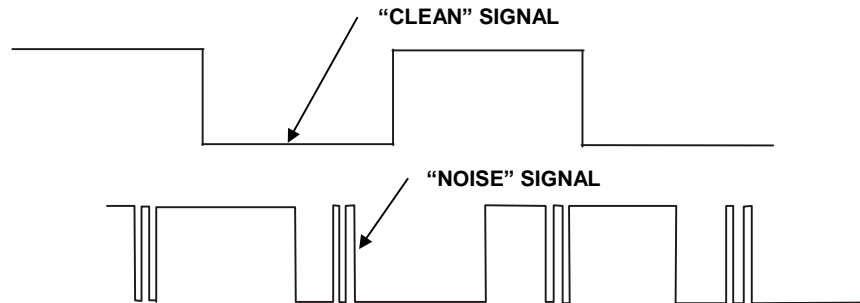
Turn knobs and verify that there is no noise on channel "A" or channel "B."

Turning knobs clockwise will be displayed as a "positive 1" direction, counterclockwise will be displayed as a "negative 1" direction. Another indication of noise is if the display fluctuates between negative and positive 1, while turning the knob in a constant direction.

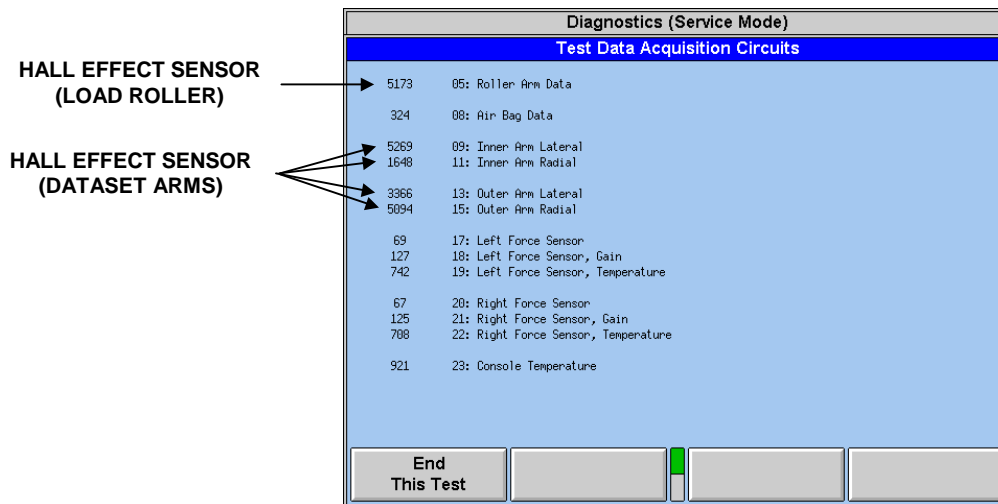
Selecting “Data Acquisition Circuits” will provide real time numbers for each channel.

When testing the Hall effect circuits, the approximate range for the sensor circuits is 1100 - 6800. Due to the allowed range of motion for each Dataset® arm, the extents of this range may not always be obtainable by each channel.

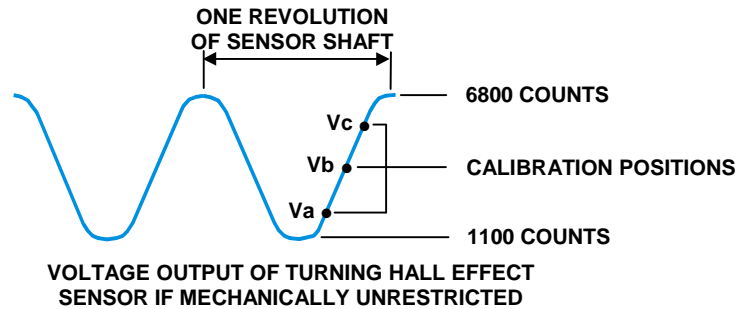
With the exception of the inner arm radial sensor, outputs are mechanically restricted to operate in the increasing portion of the sensor output as shown above. The inner arm radial can operate in the down as well as the up position, therefore has two sets of 3-point calibrations in its cal procedure. Its response (the numbers you see on the screen) will increase, peak, and then decrease as it is moved through its range.

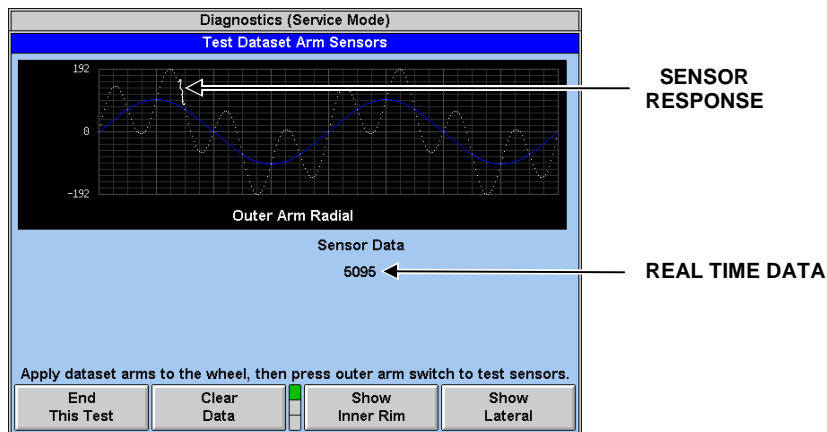
Look for noise and sensor response in radial and lateral directions. A “perfect wheel” that has no runout, will give a flat line response (the same as if the sensor is not working). If this situation occurs, simply input a small amount of runout manually (by pulling on the Dataset® arm slightly). If a flat line response is still indicated, the sensor should be replaced.

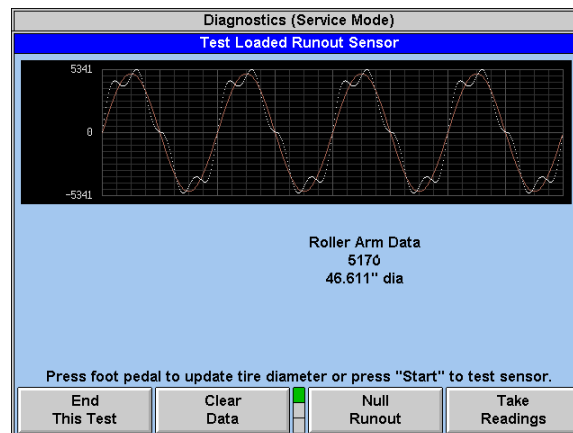
Or, press “Null Runout” to enter the initial arm (resting) position. Press “Take Readings” and just pull the load roller forward (stay under 1/2 inch movement to avoid “clipping”) a few times to collect data.

Inspect the corresponding data. The number of peaks or valleys should correspond to the runout in the wheel assembly, or to the number of times that the load roller was pulled forward (if moved manually).

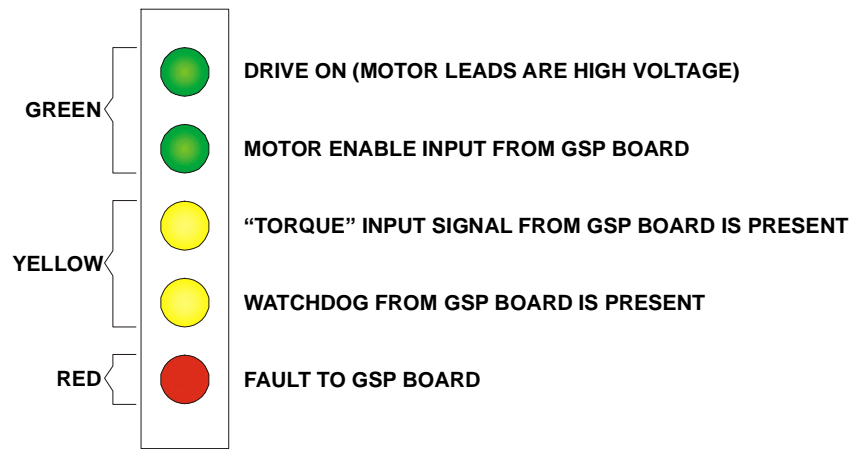
**RED: FAULT**

Indicates a fault within the drive or a lack of the required “torque” and “watchdog” signals from the GSP Board.

**⚠ WARNING:** The top "Drive On" LED is on even when the wheel is servoing in position (no shaft movement produced). The voltage present at the motor leads is still as potentially lethal as during a spin.

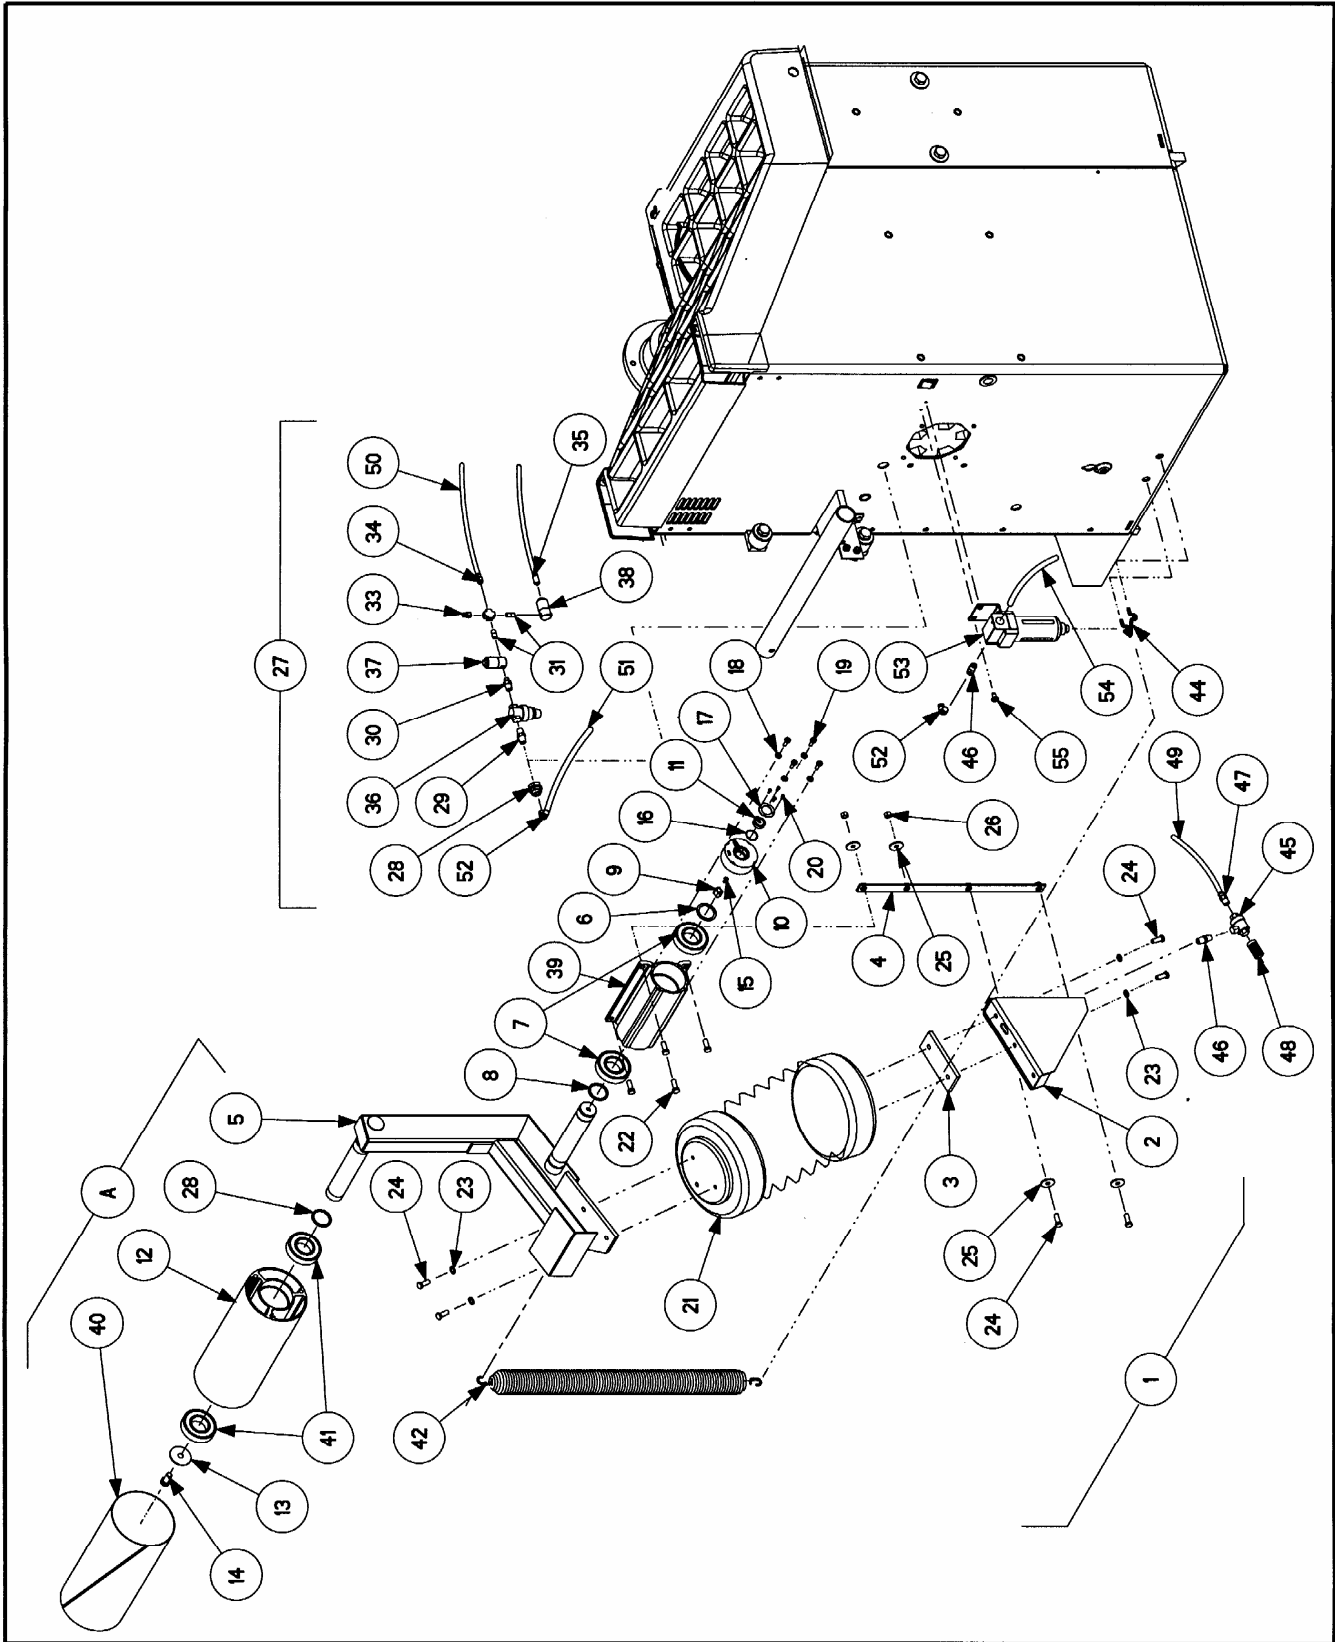
GSP9702

*Refer to Inflation Station System Schematic, page 6-5. If Control Valve "B" leaks air, it will cause the quick exhaust to shift and subsequently leak. Therefore, if the quick exhaust is leaking, Control Valve "B" should be checked (and replaced if necessary) before replacing the quick exhaust.*

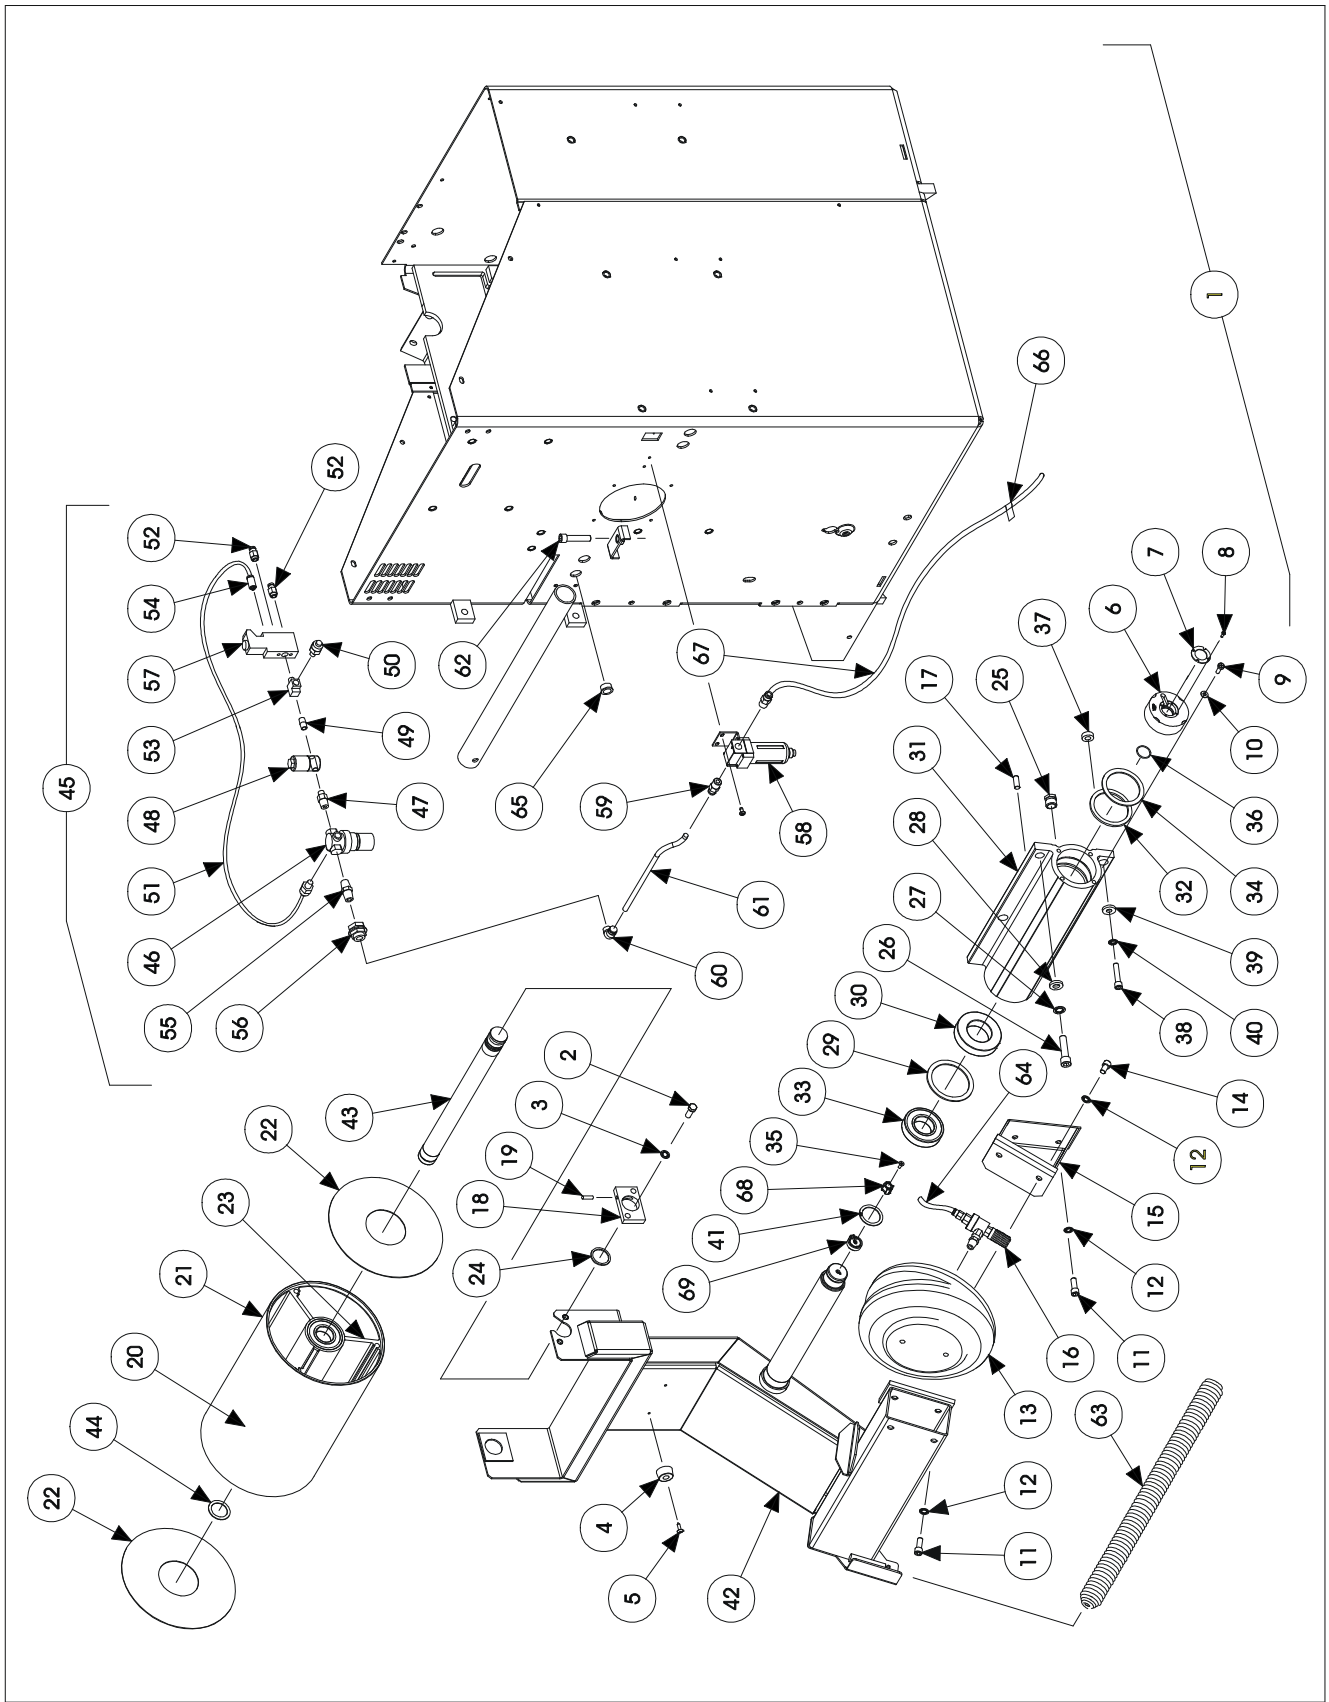
GSP9712

*Refer to Inflation Station System Schematic, page 6-5. If Control Valve "B" leaks air, it will cause the quick exhaust to shift and subsequently leak. Therefore, if the quick exhaust is leaking, Control Valve "B" should be checked (and replaced if necessary) before replacing the quick exhaust.*

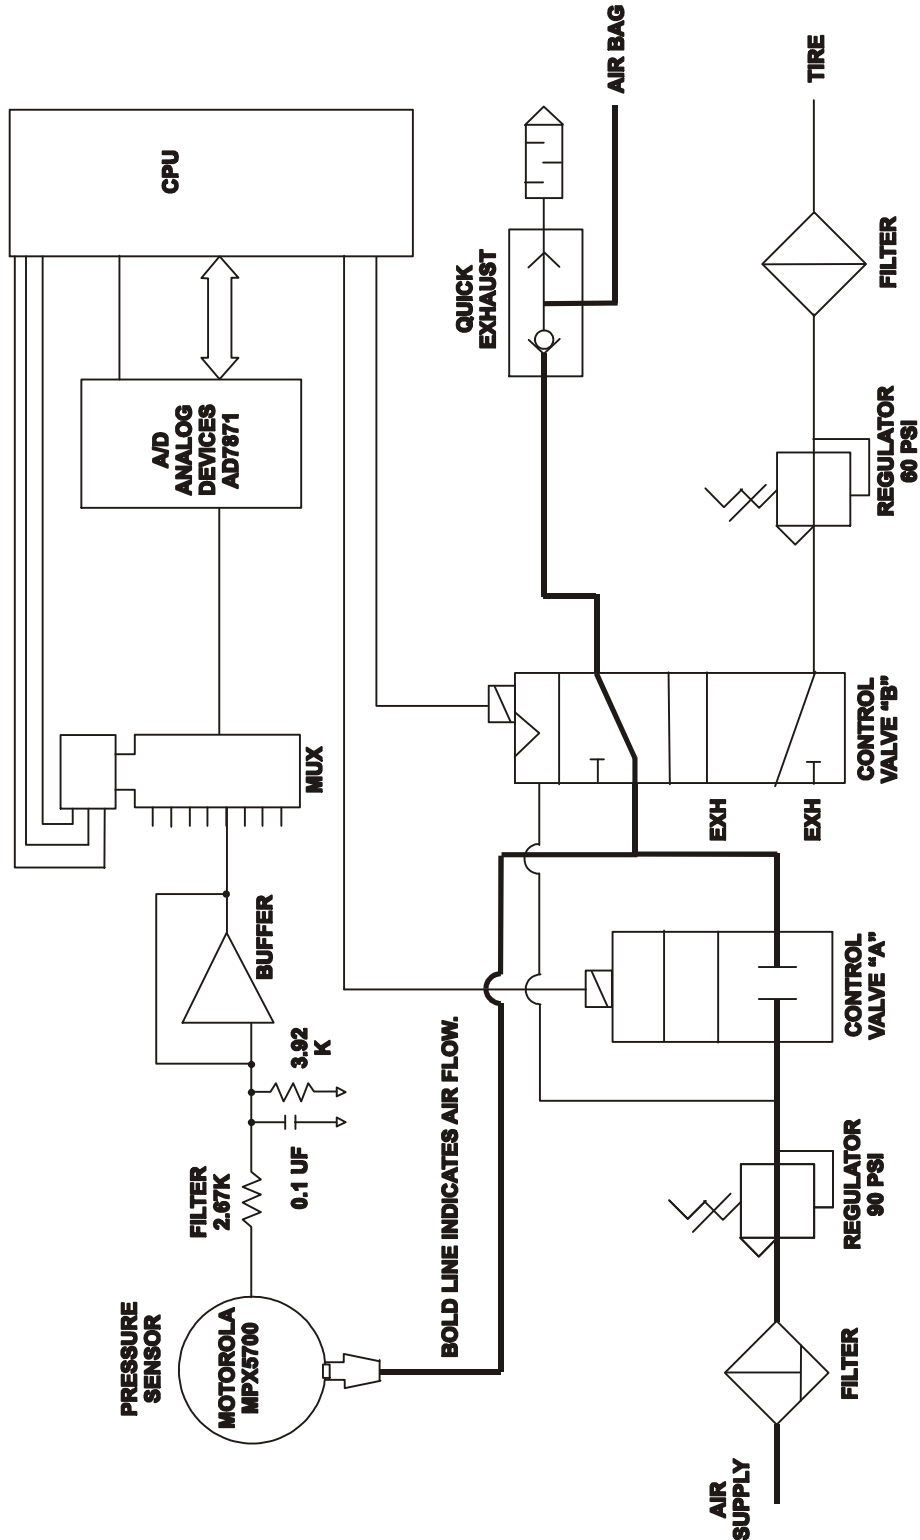
**NOTE: CHECK CONTROL VALVE "B" FOR LEAKS (AND REPLACE IF NECESSARY) BEFORE REPLACING THE QUICK EXHAUST.**

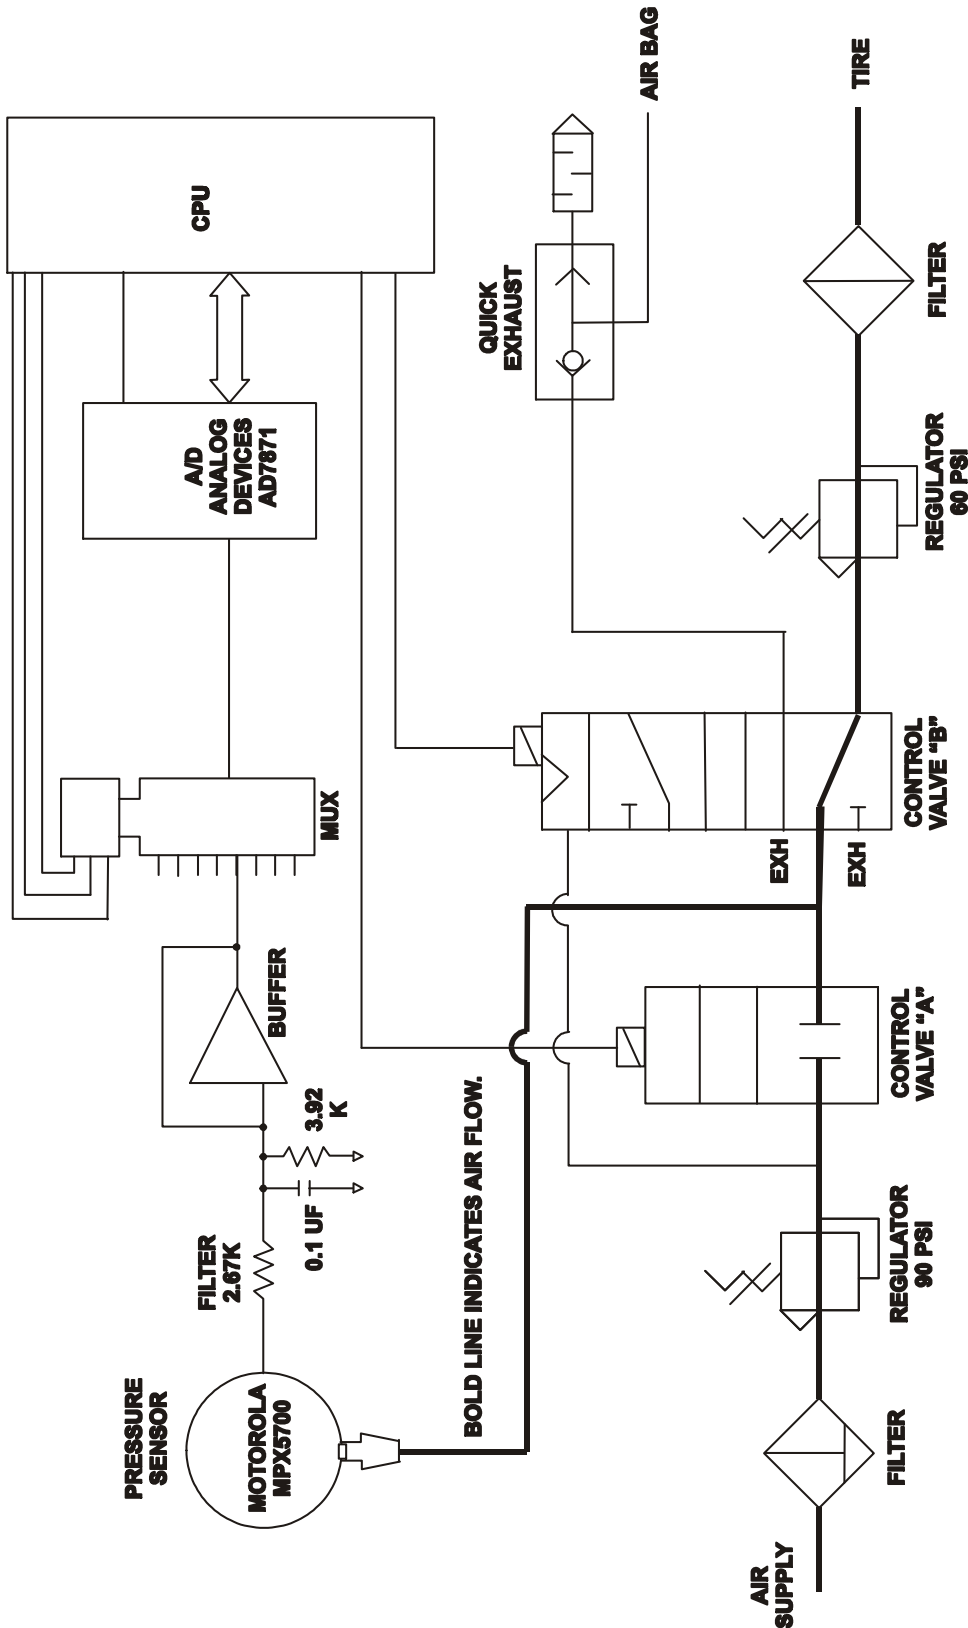
## Fill Tire

When control valve "A" is "ON" and control valve "B" is "OFF," the air pressure sensor is reading the tire pressure and filling the tire. If the tire does not inflate, remove the line at the 60 psi regulator or outlet of control valve "B" and retest. If no air is present, remove the air pressure sensor line and retest. Replace valves or regulators as necessary.

**NOTE: CHECK CONTROL VALVE "B" FOR LEAKS (AND REPLACE IF NECESSARY) BEFORE REPLACING THE QUICK EXHAUST.**

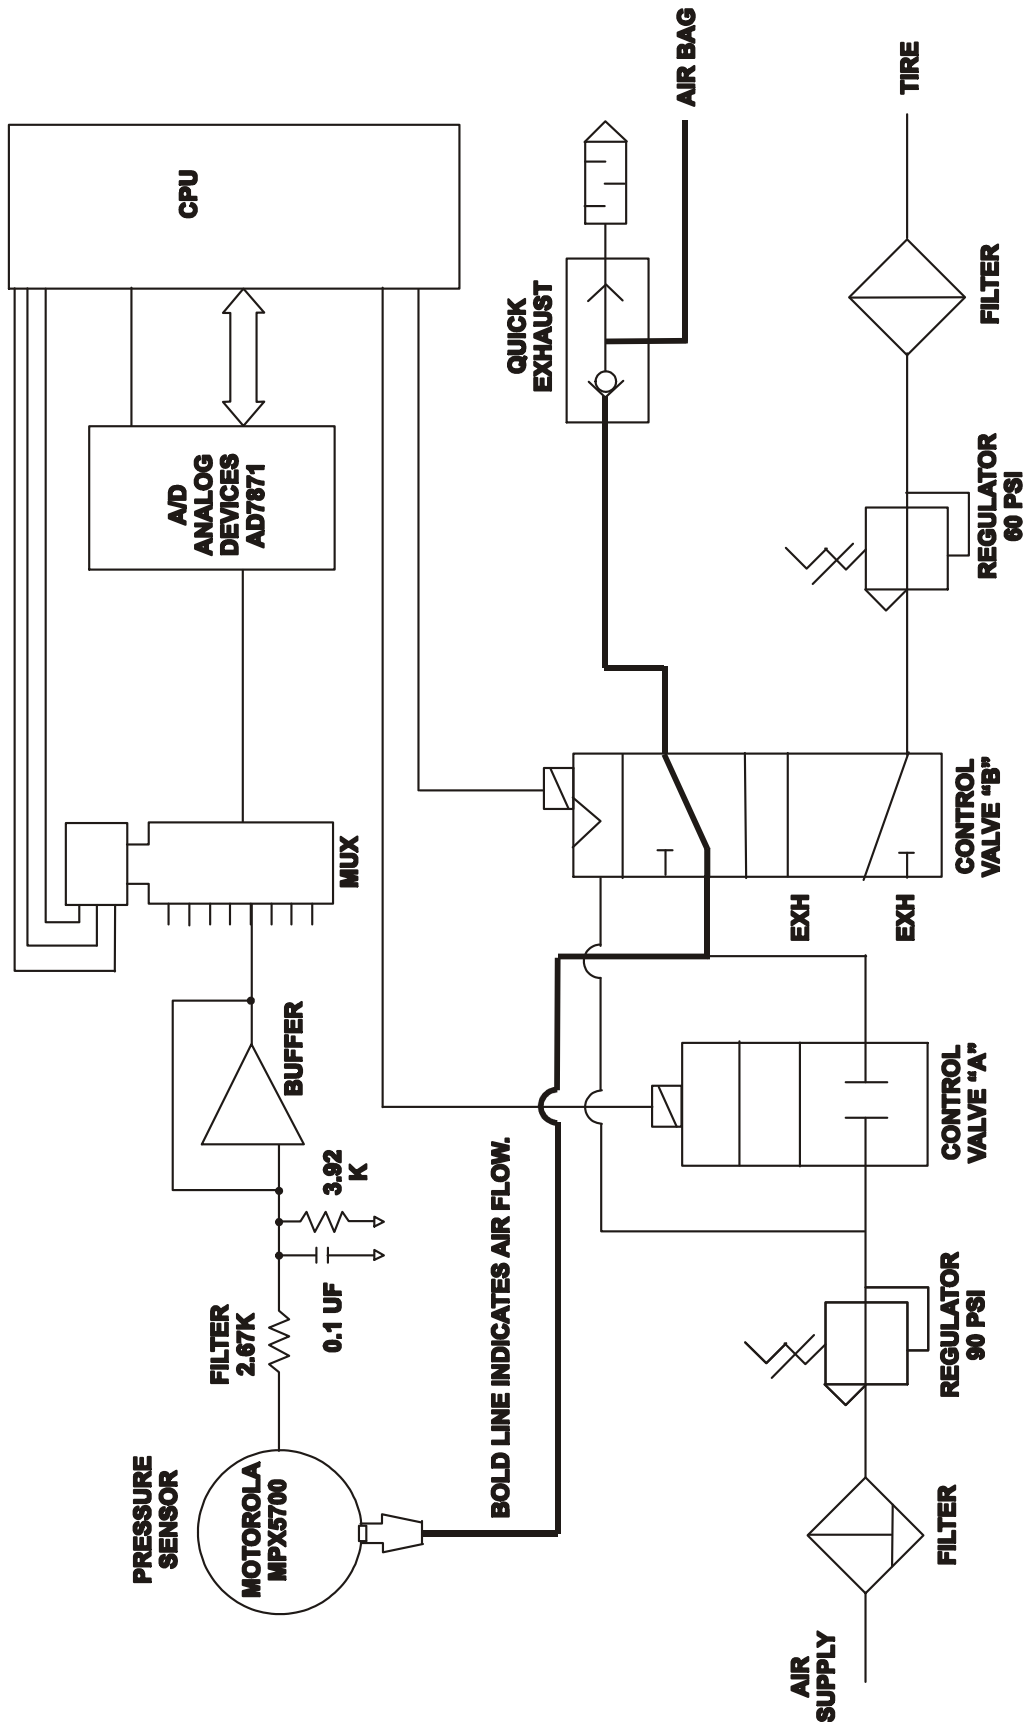
## Read Air Bag

When control valve "A" is "OFF" and control valve "B" is "ON," the air pressure sensor is reading the air bag pressure or deflating the tire.

**NOTE: CHECK CONTROL VALVE "B" FOR LEAKS (AND REPLACE IF NECESSARY) BEFORE REPLACING THE QUICK EXHAUST.**

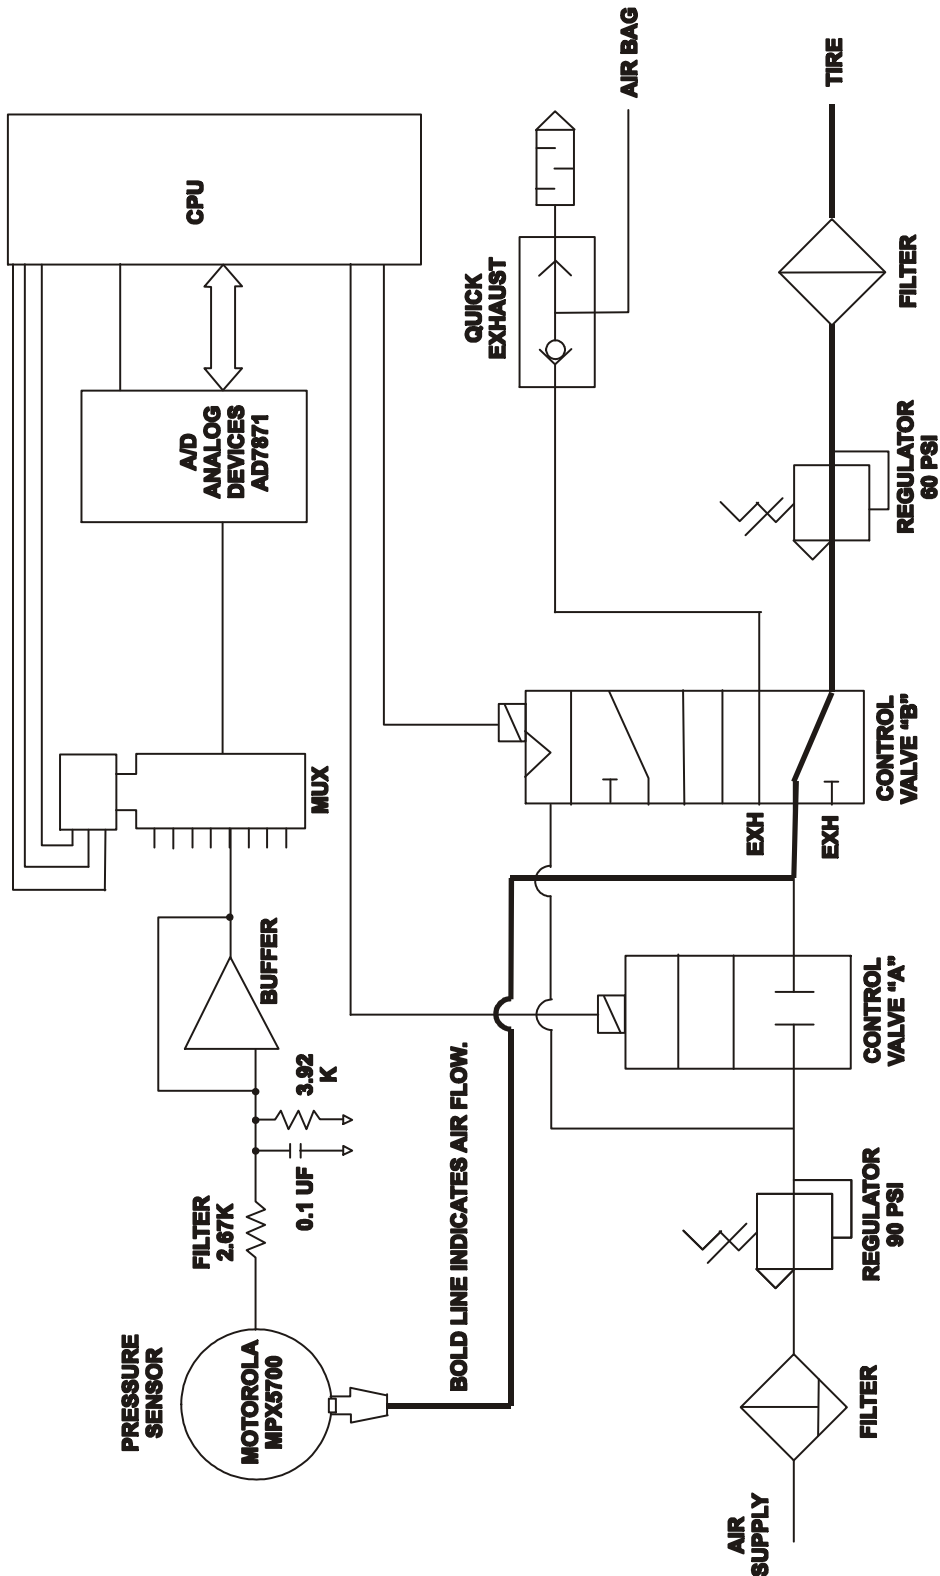
## Read Tire

When both control valves are "OFF," the air pressure sensor is reading the tire pressure. If the tire pressure display does not come up on the screen when the inflation hose is connected to a tire, disconnect the air pressure sensor line, connect the inflation hose to a tire, and verify that air pressure is coming back to the sensor. If no air pressure is present, disconnect the air line at control valve "B" to check for air pressure there.

**NOTE: CHECK CONTROL VALVE "B" FOR LEAKS (AND REPLACE IF NECESSARY) BEFORE REPLACING THE QUICK EXHAUST.**
